## CHAPTER V

# STRUCTURAL DAMAGE FROM AIR BLAST

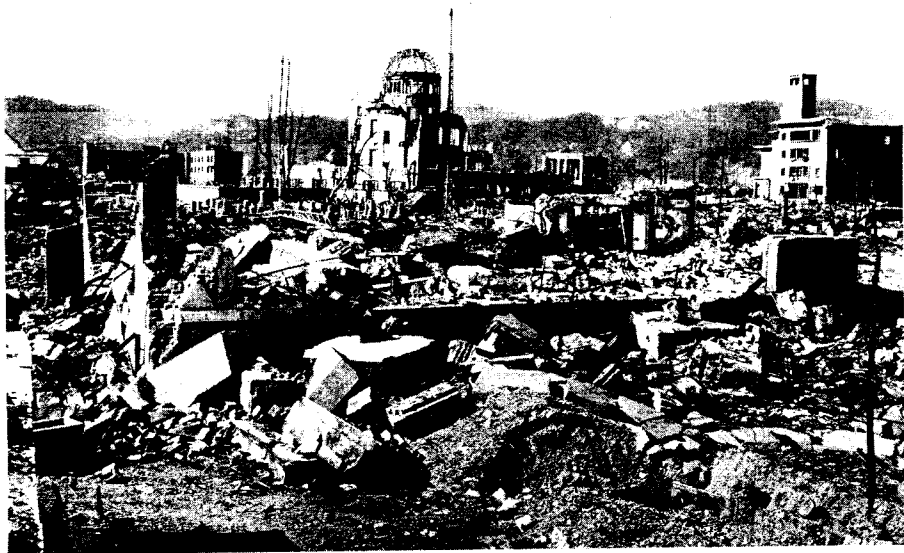
Figure 5.06. Debris after the nuclear explosion at Hiroshima.

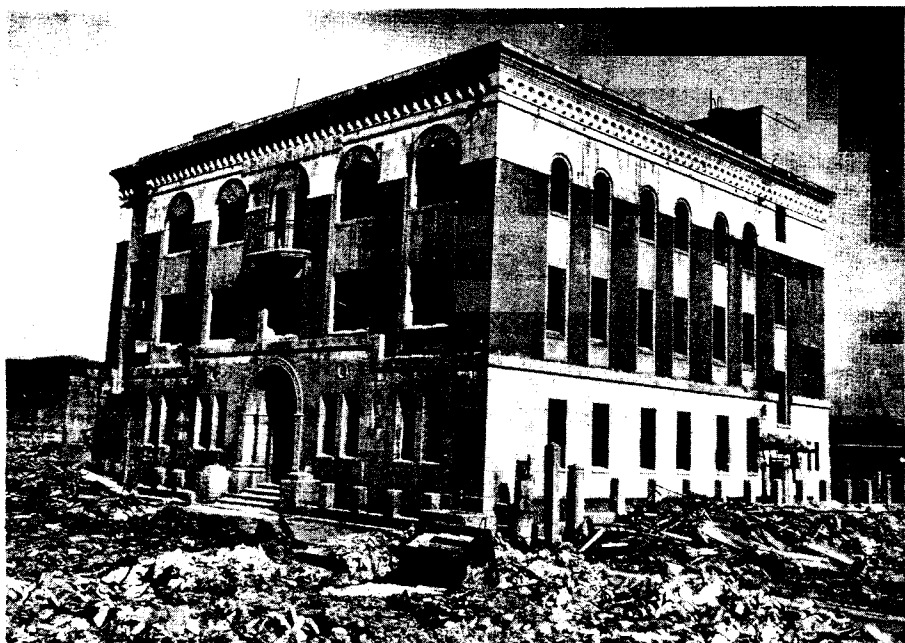
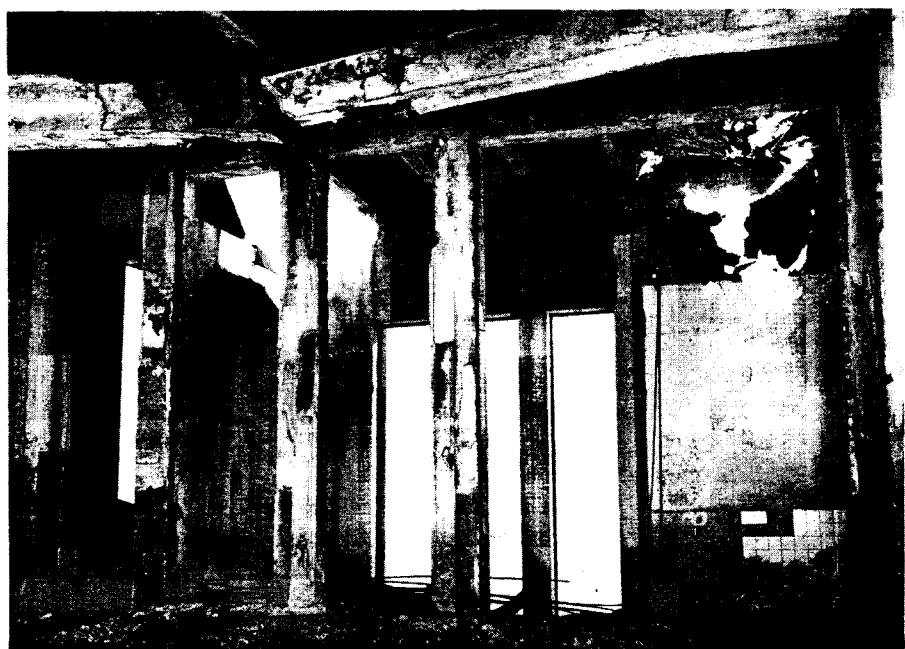
the interior and contents due to the entry of blast through doors and window openings and to subsequent fires. An exceptionally strong structure of earthquake-resistant (aseismic) design, located some 640 feet from ground zero in Hiroshima, is seen in Fig. 5.20a. Although the exterior walls were hardly damaged, the roof was depressed and the interior was destroyed. More typical of reinforced-concrete frame construction in the United States was the building shown in Fig. 5.20b at about the same distance from ground zero. This suffered more severely than the one of aseismic design.

Figure 5.20a. Upper photo: Reinforced-concrete, aseismic structure; window fire shutters were blown in by blast and the interior gutted by fire (0.12 mile from ground zero at Hiroshima). Lower photo: Burned out interior of similar structure.

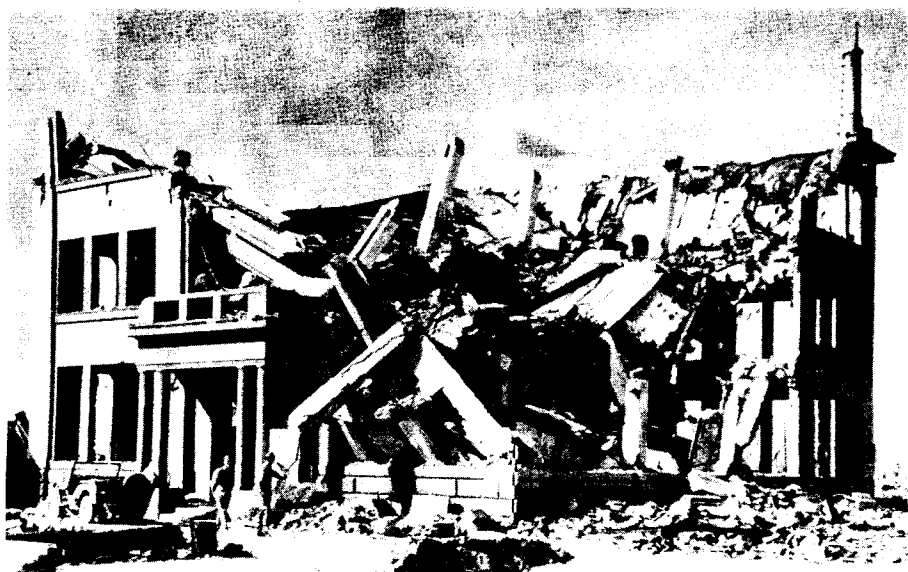
Figure 5.20b. Three-story, reinforced-concrete frame building; walls were 13-inch thick brick panel with large window openings (0.13 mile from ground zero at Hiroshima).

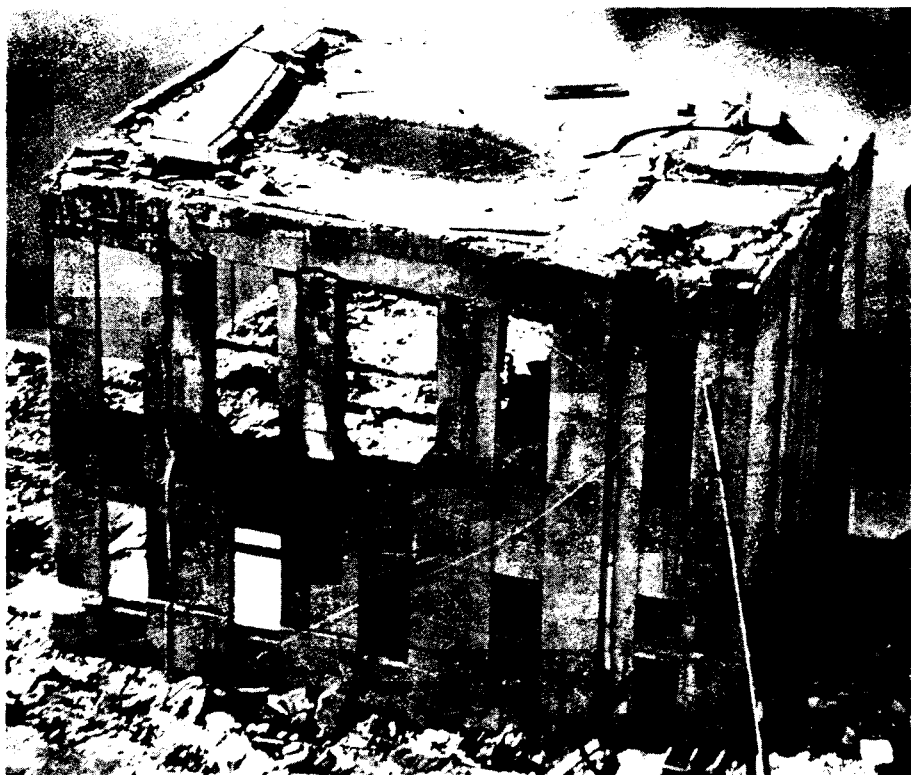
**5.22** Close to ground zero the vertical component of the blast was more significant and so greater damage to the roof resulted from the downward force (Fig. 5.22a) than appeared farther away. Depending upon its strength, the roof

was pushed down and left sagging or it failed completely. The remainder of the structure was less damaged than similar buildings farther from the explosion because of the smaller horizontal (lateral) forces. At greater distances, from ground zero, especially in the region of Mach reflection, the consequences of horizontal loading were apparent (Fig. 5.22b).

Figure 5.22a. Depressed roof of reinforced-concrete building (0.10 mile from ground zero at Hiroshima).

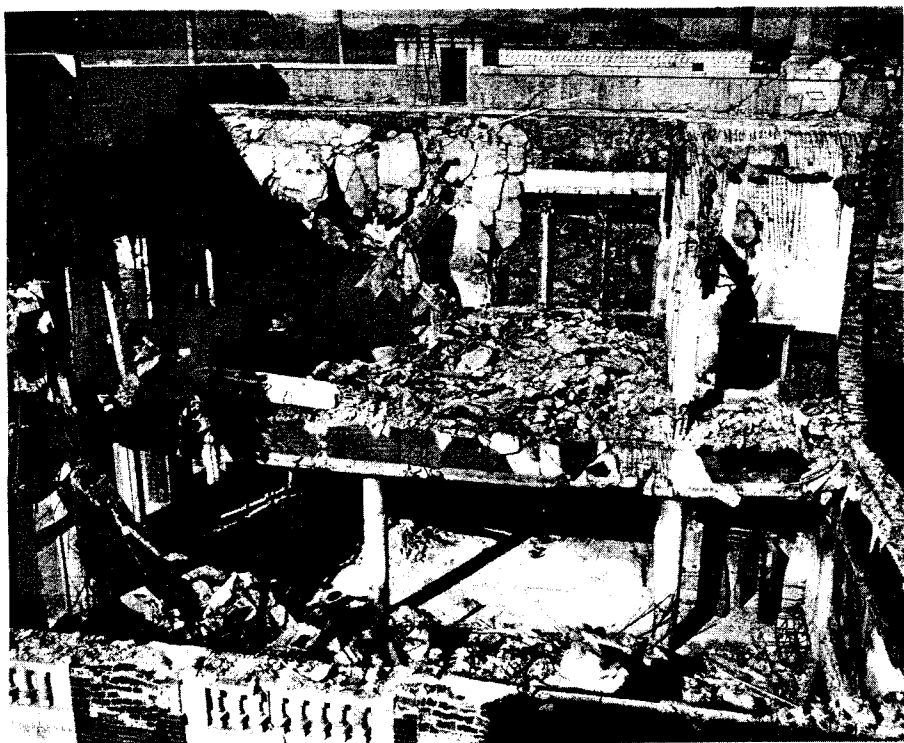
5.23 In addition to the failure of roof slabs and the lateral displacement of walls, numerous other blast effects were observed. These included bending and fracture of beams, failure of columns, crushing of exterior wall panels, and failure of floor slabs (Fig. 5.23). Heavy damage to false ceilings, plaster, and partitions occurred as far out as 9,000 feet (1.7 miles) from ground zero, and glass windows were generally bro-

Figure 5.23. Reinforced-concrete building showing collapsed roof and floor slabs (0.10 mile from ground zero at Nagasaki).

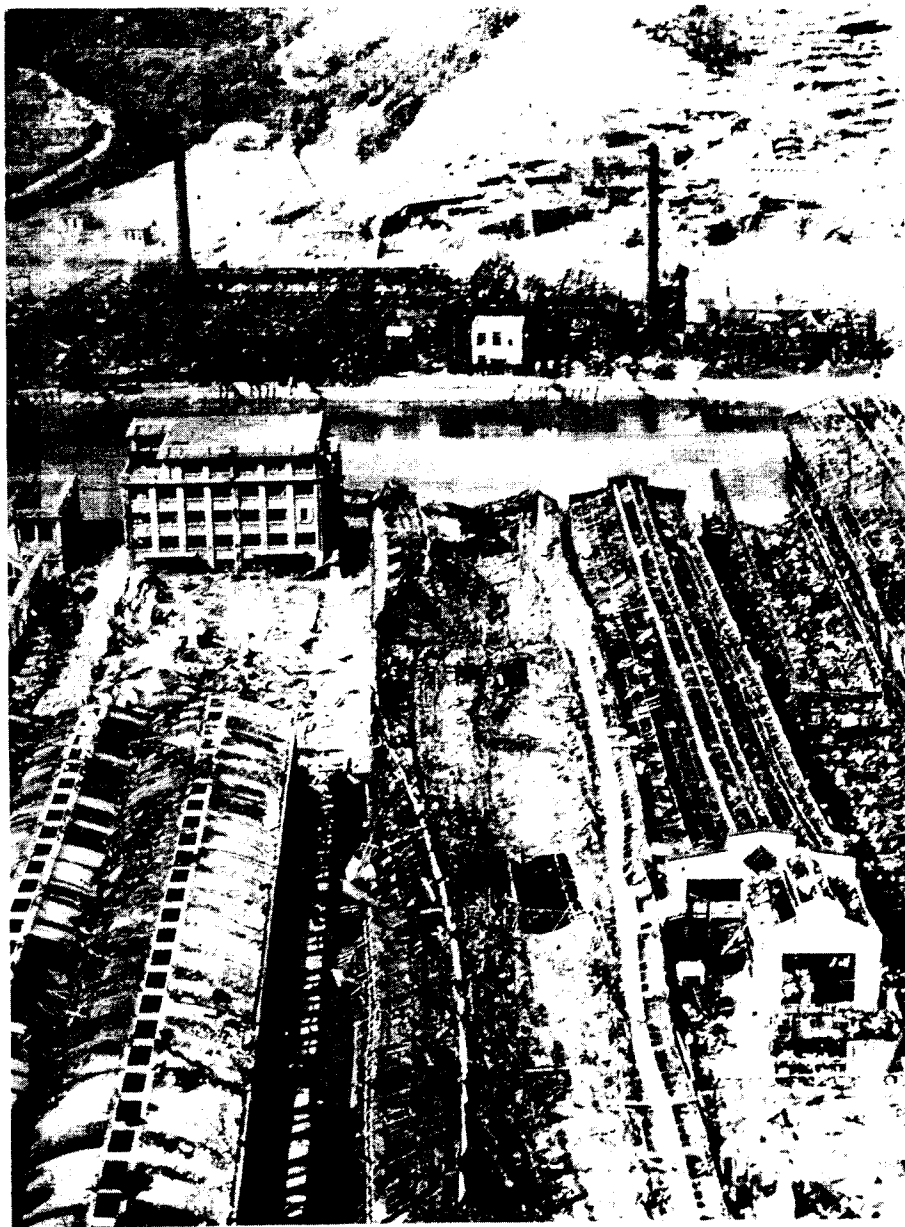
ground zero (Fig. 5.25). The only part of the building that was not regarded as being of heavy construction was the roof, which was of 4-inch thick reinforced concrete supported by unusually light steel trusses. The downward failure of the roof, which was dished 3 feet, was the only important structural damage suffered.

Figure 5.25. At left and back of center is a multistory, steel-frame building (0.85 mile from ground zero at Nagasaki).

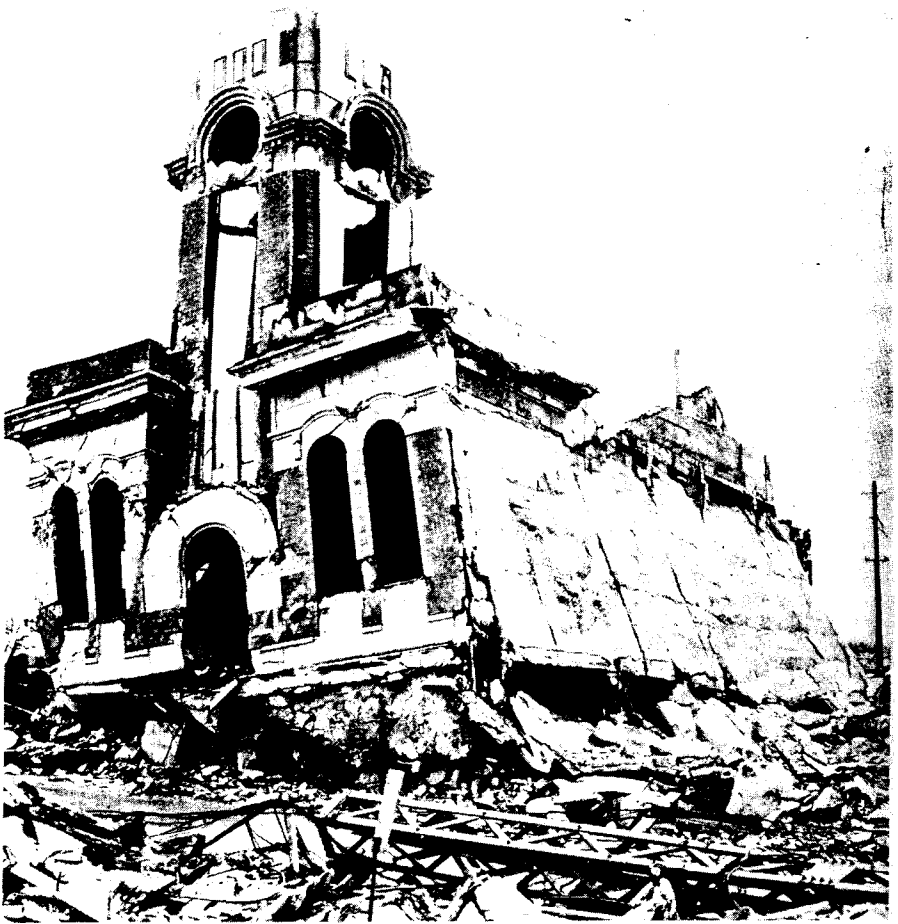
shown in Fig. 5.26. The heavy walls of the structure transmitted their loads to the steel frame, the columns of which collapsed. Weakening of unprotected steel by fire could have contributed significantly to the damage to steel-frame structures (§ 5.31).

Figure 5.26. Two-story, steel-frame building with 7-inch reinforced-concrete wall panels (0.40 mile from ground zero at Hiroshima). The first story columns buckled away from ground zero dropping the second story to the ground.

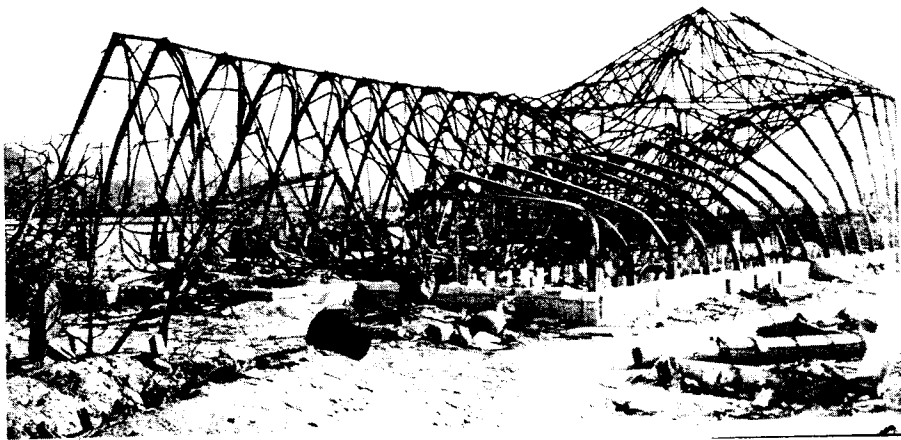
5.29 Severe damage of these structures occurred up to a distance of about 6,000 feet (1.14 miles) from ground zero. Moderately close to ground zero, the buildings were pushed over bodily, and at greater distances they were generally left leaning away from the source of the blast (Fig. 5.29). The columns being long and slender offered little resistance to the lateral loading. Sometimes columns failed due to a lateral

force causing flexure, combined with a simultaneous small increase in the downward load coming from the impact of the blast on the roof. This caused buckling and, in some instances, complete collapse. Roof trusses were buckled by compression resulting from lateral blast loading on the side of the building facing the explosion.

Figure 5.29. Single-story, light steel-frame building (0.80 mile from ground zero at Hiroshima); partially damaged by blast and further collapsed by subsequent fire.

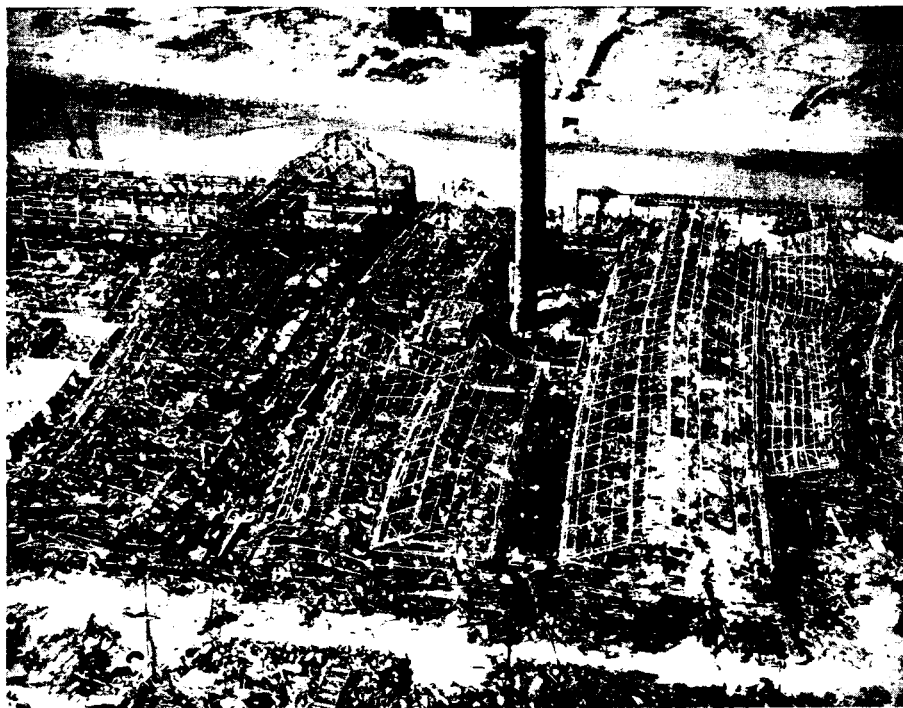
**5.34** Smokestacks, especially those of reinforced concrete, proved to have considerable blast resistance (Fig. 5.34a). Because of their shape, they are subjected essentially to drag loading only and, if sufficiently strong, their long period of vibration makes them less sensitive to blast than many other structures. An example of extreme damage to a reinforced-concrete stack is shown in Fig. 5.34b. Steel smokestacks performed reasonably well, but being lighter in weight and subject to crushing were not comparable to reinforced concrete. On the whole, well-constructed masonry stacks withstood the blast

Figure 5.34a. Destroyed industrial area showing smokestacks still standing (0.51 mile from ground zero at Nagasaki).

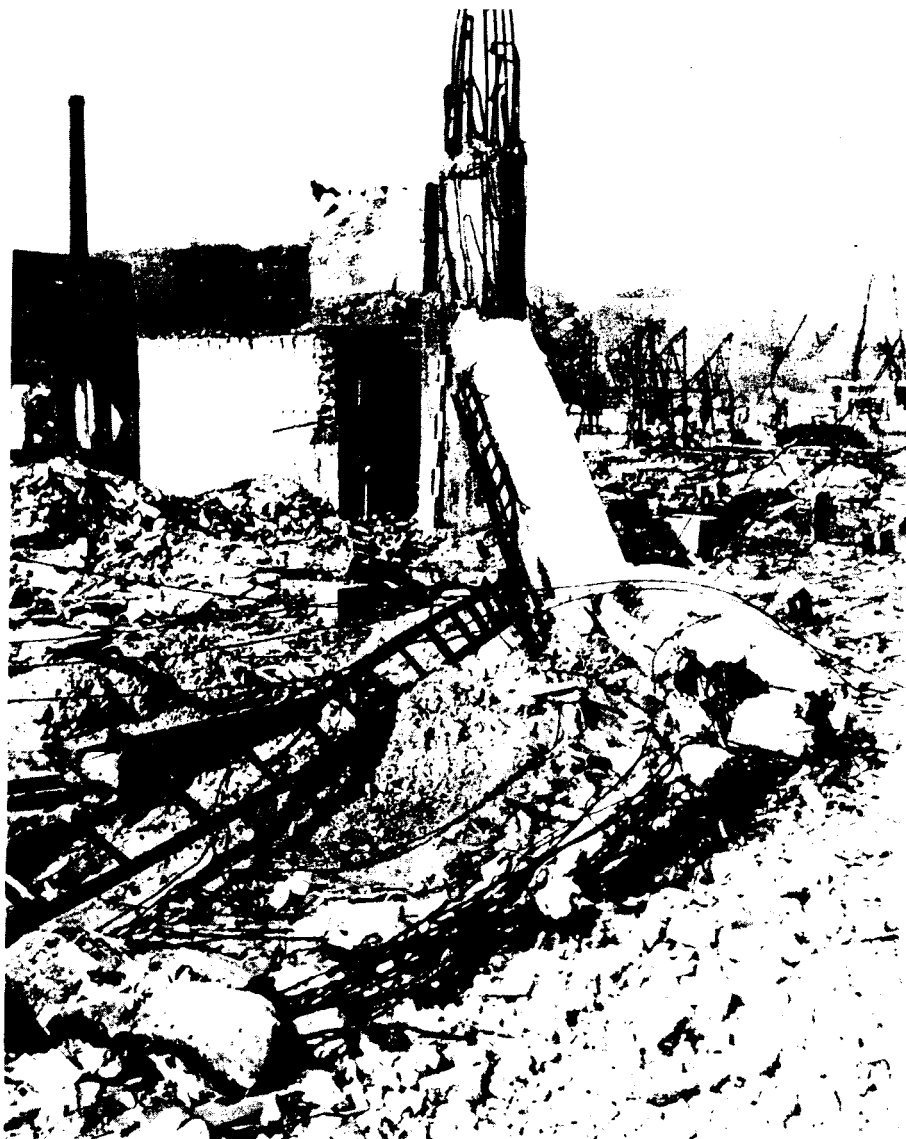
Figure 5.34b. A circular, 60 feet high, reinforced-concrete stack (0.34 mile from ground zero at Hiroshima). The failure caused by the blast wave occurred 15 feet above the base.

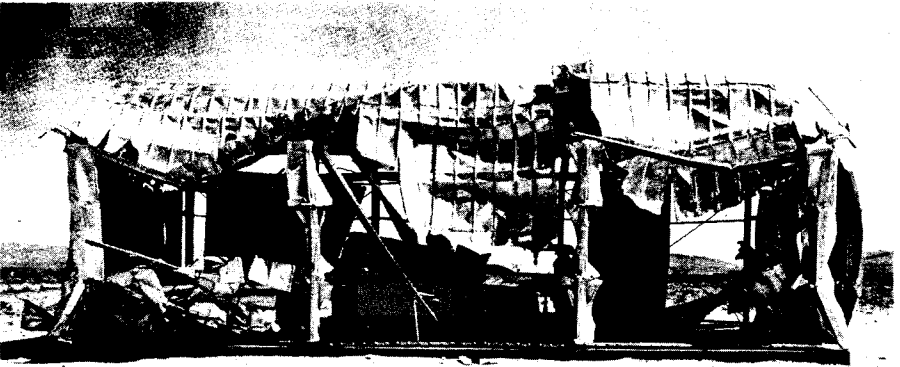
**5.37** The first industrial type building had a conventional rigid steel frame, which is familiar to structural engineers, with aluminum-sheet panels for roofing and siding (Fig. 5.37a). At a blast overpressure of 3.1 pounds per square inch this building was severely damaged. The welded and bolted steel frame

Figure 5.37b. Rigid steel-frame building after a nuclear explosion (3.1 psi peak overpressure).

**5.39** As presently designed, structures of this type may be regarded as being repairable, provided they are not exposed to blast pressures exceeding 1 pound per square inch. Increased blast resistance would probably result from improvement in the design of girts and purlins (horizontal members supporting rafters), in particular. Better fastening between sill and wall footing and increased resistance to transverse loading would also be beneficial.

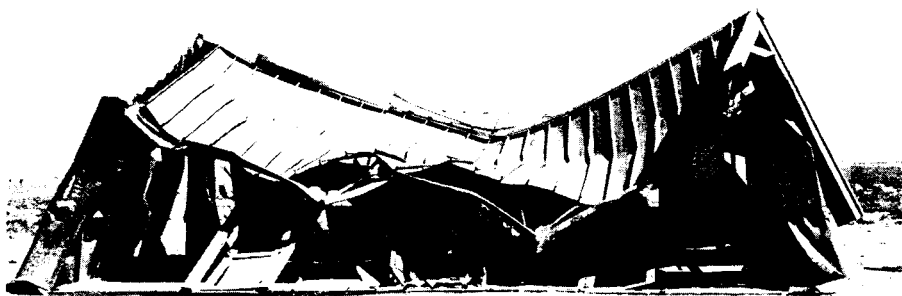
0.2 pound per square inch) was completely demolished (Fig. 5.40b). One or two segments of wall were blown as far as 50 feet away, but, in general, the bent and twisted segments of the building remained approximately in their original locations. Most of the wall sections were still attached to their foundation bolts on the side and rear walls of the

Figure 5.40b. Self-framing steel panel building after a nuclear explosion (3.1 psi peak overpressure).

5.42 It appears that the steel panel type of structure is repairable if exposed to overpressures of not more than about  $\frac{3}{4}$  to 1 pound per square inch. The buildings are simple to construct but they do not hold together well under

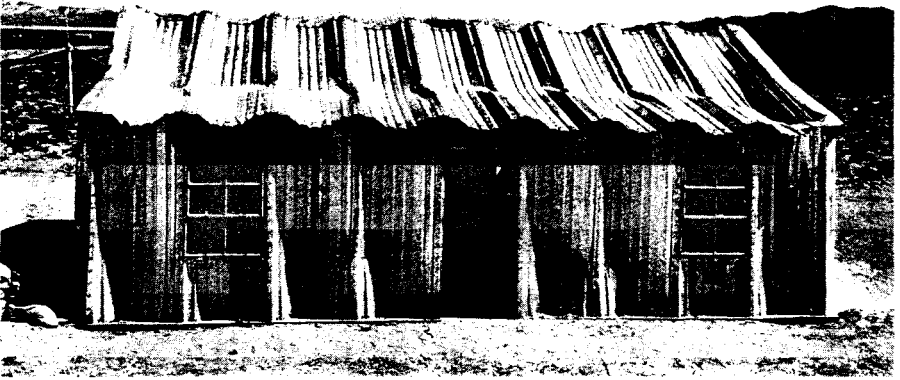
Figure 5.44. Self-framing corrugated steel panel building after a nuclear explosion (3.1 psi peak overpressure).

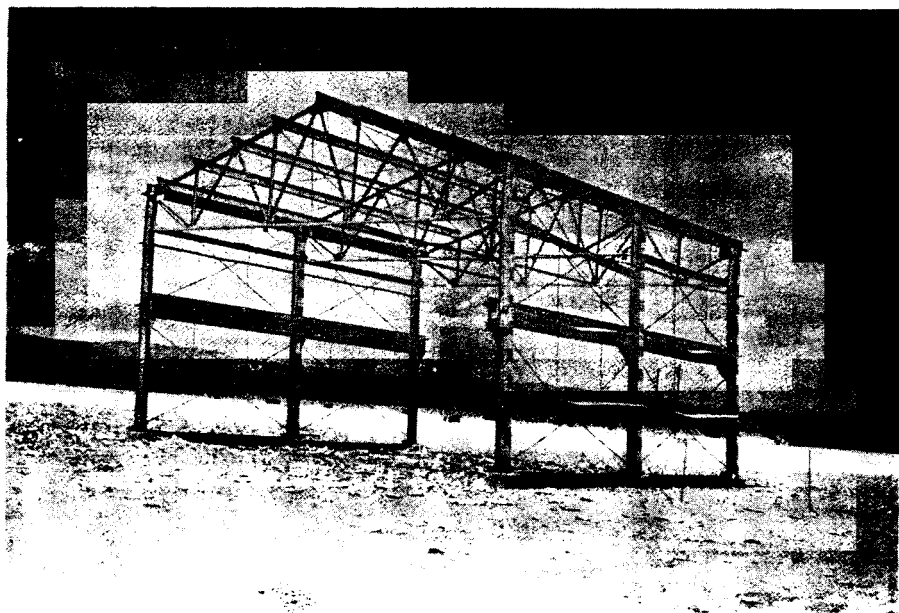
Figure 5.49. Structure in Figure 5.48a after exposure to 6.5 psi peak overpressure and 1.1 psi dynamic pressure; positive phase duration 0.9 second.

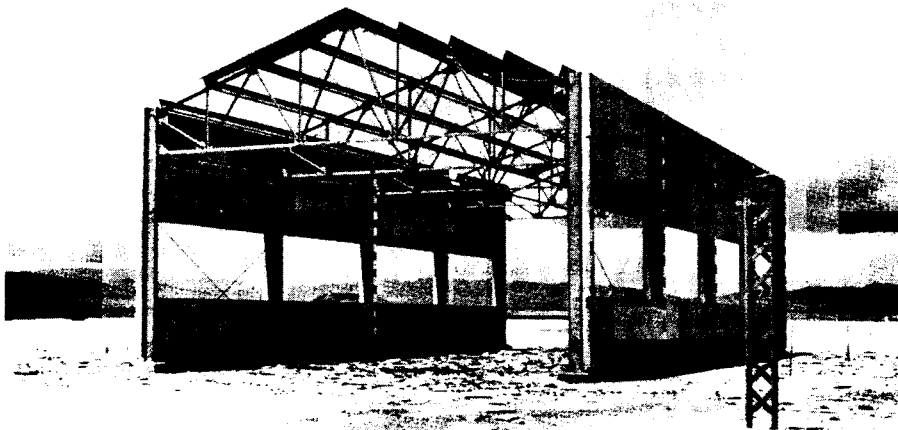
Figure 5.50. Structure in Figure 5.48b after exposure to 3.5 psi peak overpressure and 0.3 psi dynamic pressure; positive phase duration 1 second.

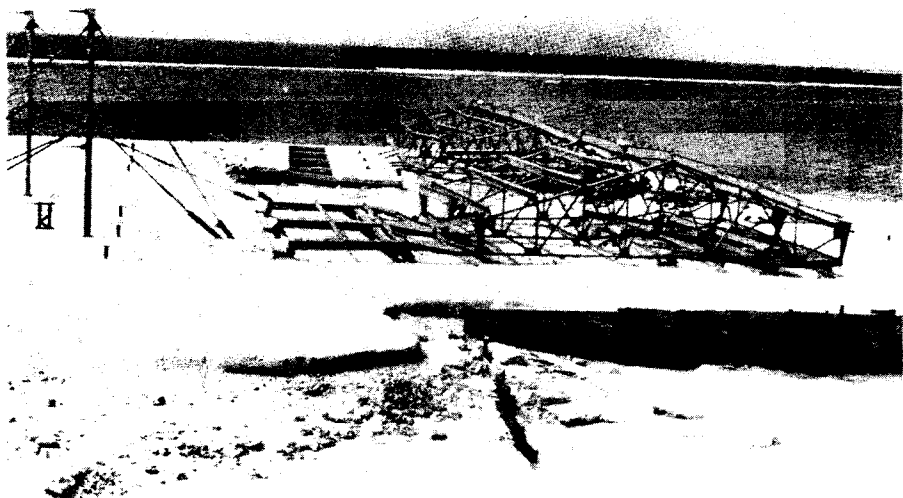
Figure 5.51a. Structure similar to Figure 5.48a after exposure to 6.1 psi peak overpressure and 0.6 psi dynamic pressure; positive phase duration several seconds.

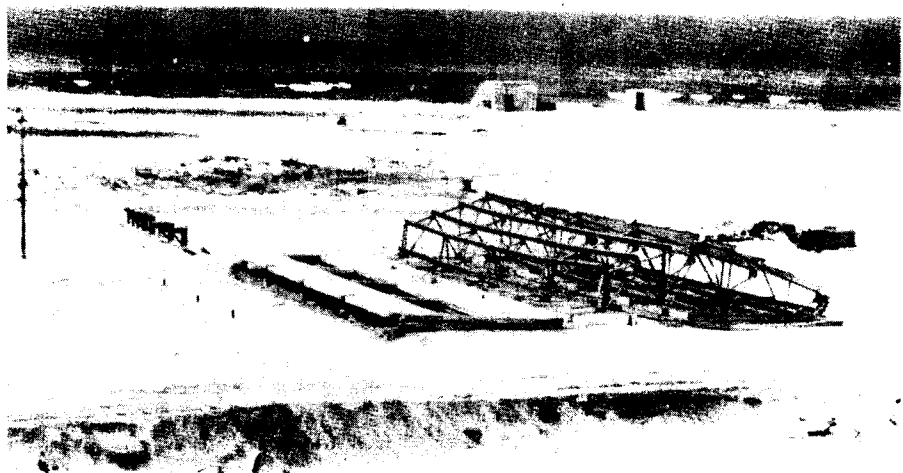
Figure 5.51b. Structure similar to Figure 5.48b after exposure to 5 psi peak overpressure and 0.5 psi dynamic pressure; positive phase duration several seconds.

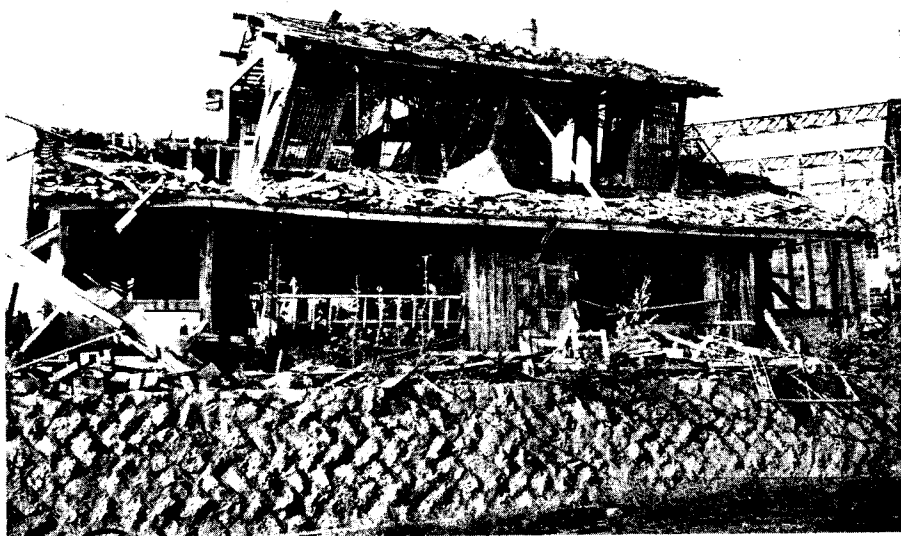
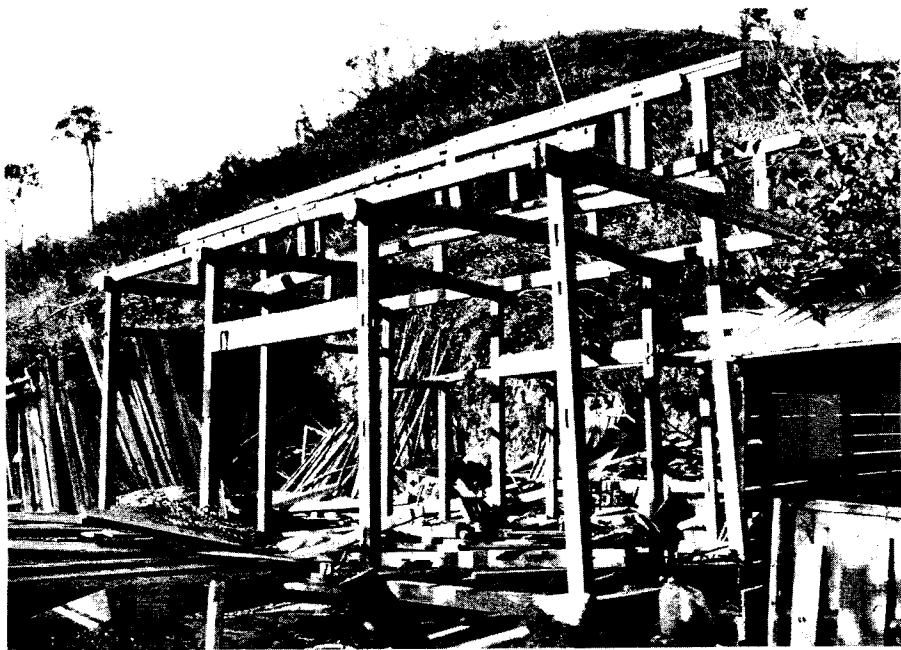
appeared that, although the quality of the workmanship in framing was usually high, little attention was paid to good engineering principles. On the whole, therefore, the construction was not well adapted to resist wracking action (distortion). For example, mortise and tenon joints were weak points in the

Figure 5.52. Upper photo; Wood-frame building; 1.0 mile from ground zero at Hiroshima.  
Lower photo: Frame of residence under construction, showing small tenons.

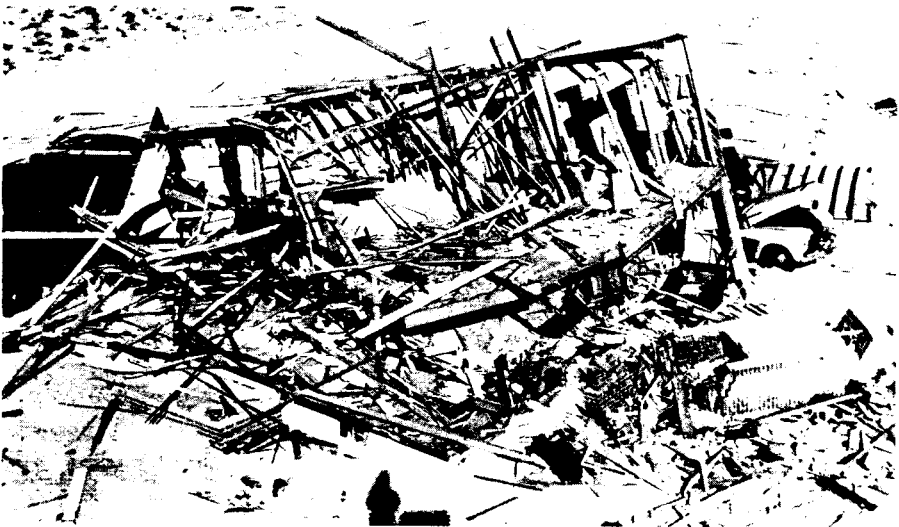
**5.57** Some indication of the blast damage suffered by this dwelling can be obtained from Fig. 5.57. It is apparent that the house was ruined beyond repair. The first story was completely demolished and the second story, which was very badly damaged, dropped down on the first floor debris. The roof was blown off in several sections which landed at both front and back of the house. The gable end walls were blown apart and outward, and the brick chimney was broken into several pieces.

Figure 5.57. Wood-frame house after a nuclear explosion (5 psi peak overpressure).

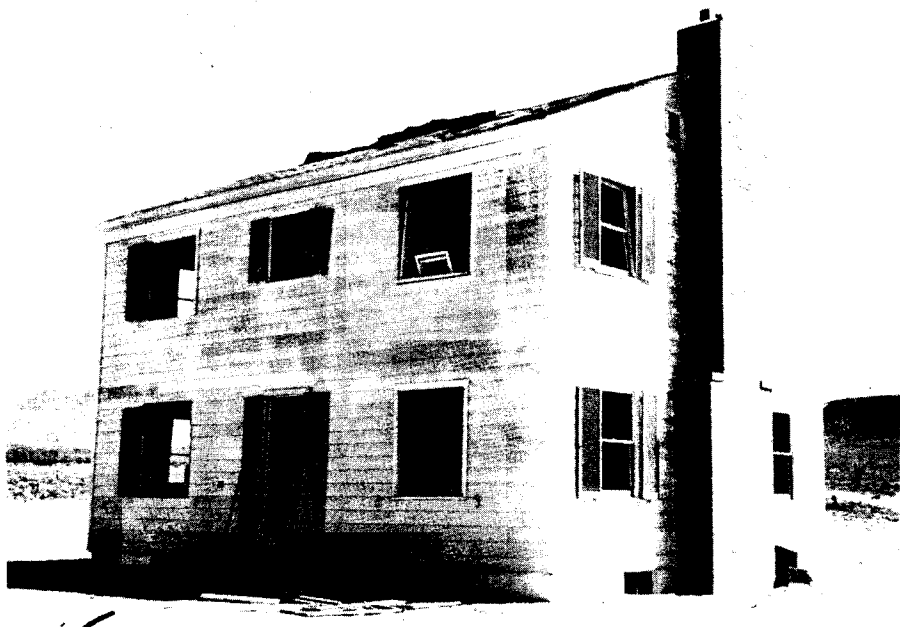
Figure 5.59. Wood-frame house after a nuclear explosion (1.7 psi peak overpressure).

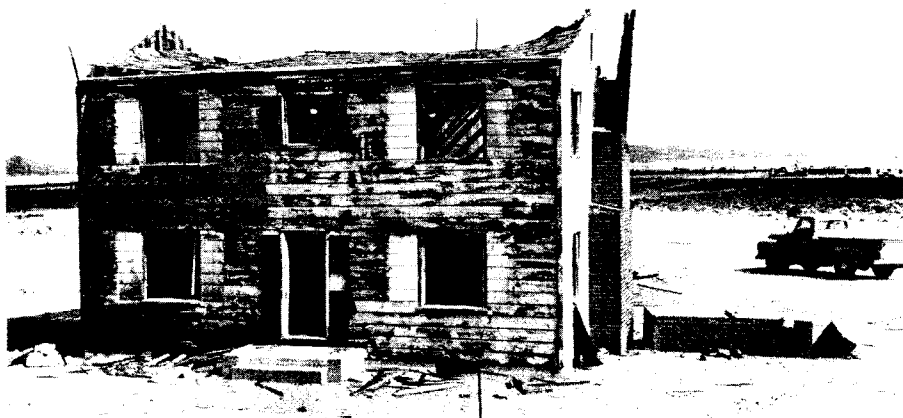
Figure 5.64. Strengthened wood-frame house after a nuclear explosion (4 psi peak overpressure).

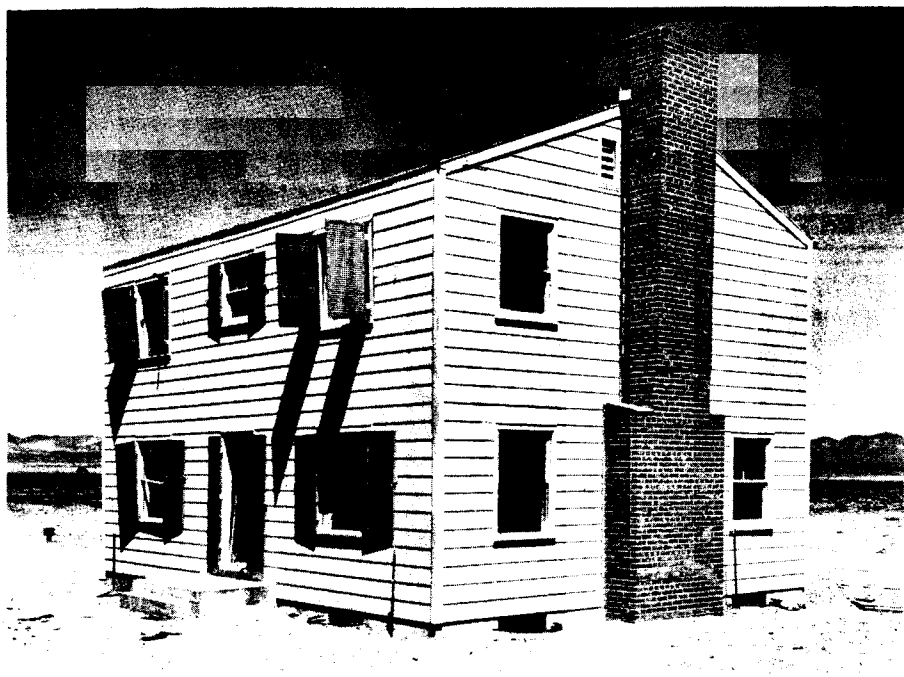
Figure 5.65. Strengthened wood-frame house after a nuclear explosion (2.6 psi peak overpressure).

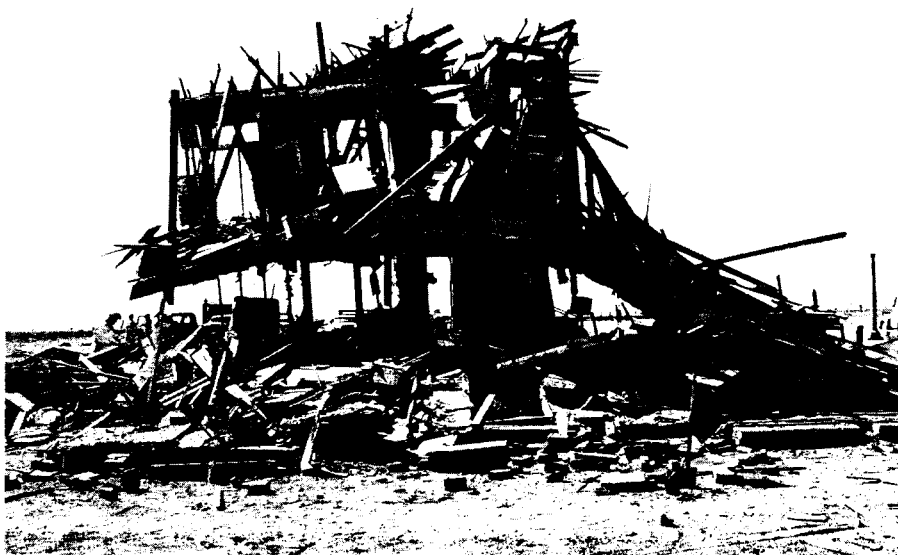
Figure 5.67. Unreinforced brick house after a nuclear explosion (5 psi peak overpressure).

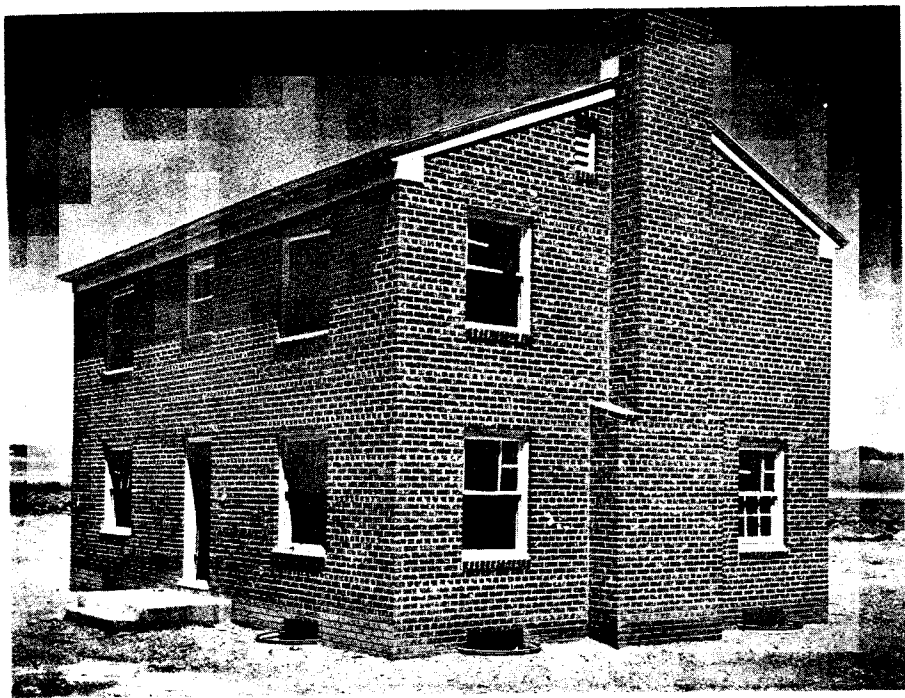
Figure 5.68. Unreinforced brick house after a nuclear explosion (1.7 psi peak overpressure).

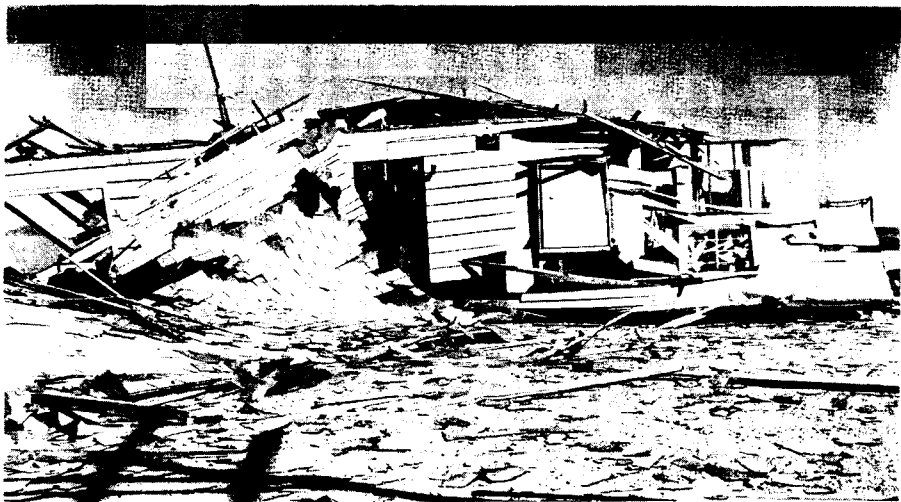
Figure 5.70. Rambler-type house after a nuclear explosion (5 psi peak overpressure).

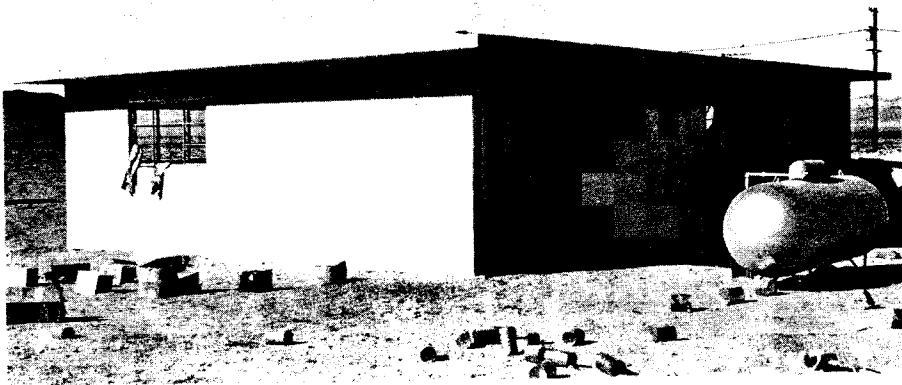
Figure 5.73. Reinforced precast concrete house after a nuclear explosion (5 psi peak overpressure). The LP-gas tank, sheltered by the house, is essentially undamaged.

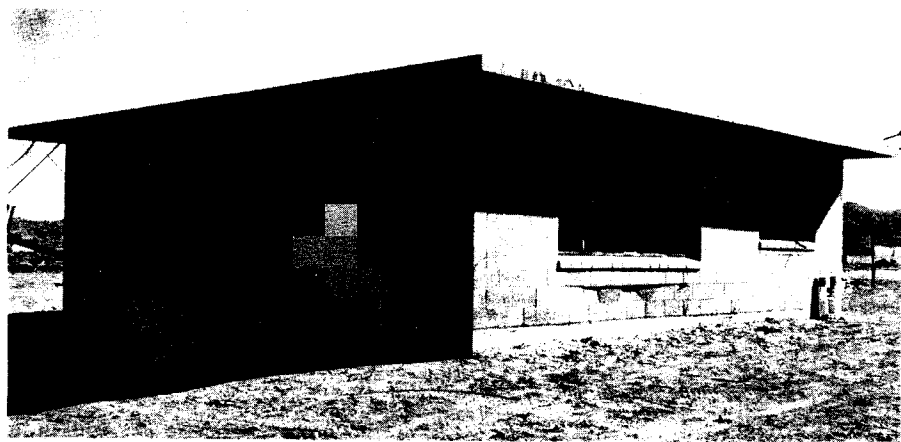
Figure 5.77. Reinforced masonry-block house after a nuclear explosion (5 psi peak overpressure).

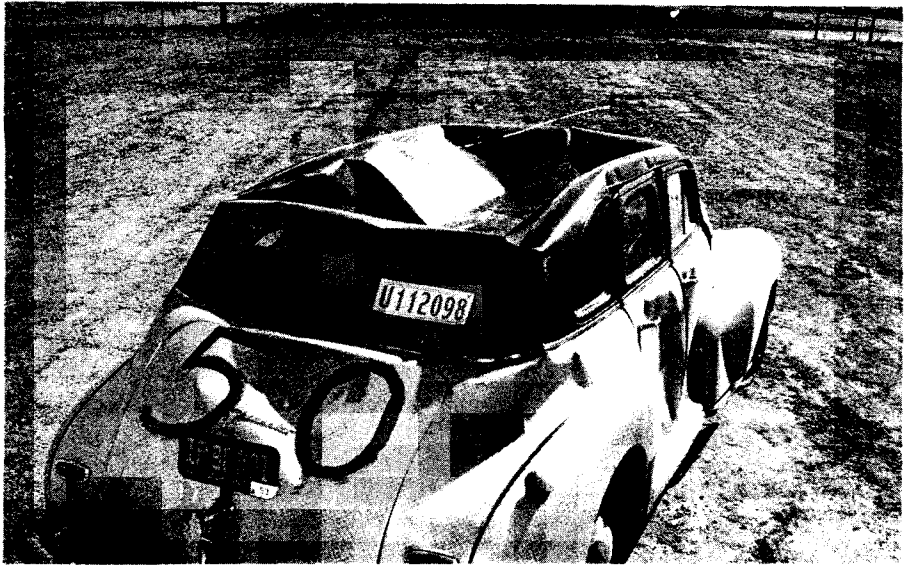
Figure 5.87a. Damage to automobile originally located behind wood-frame house (5 psi peak overpressure); the front of this car can be seen in Figure 5.57. Although badly damaged, the car could still be driven after the explosion.

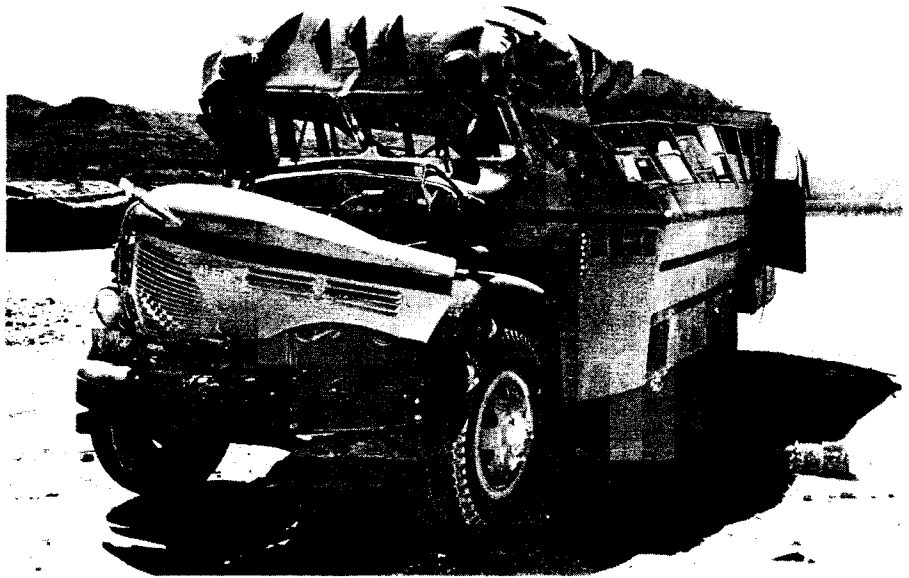
Figure 5.87b. Typical public bus damaged by a nuclear explosion, Nevada Test Site; this bus, like the one in the left background, was overturned, coming to rest as shown after a displacement of 50 feet.

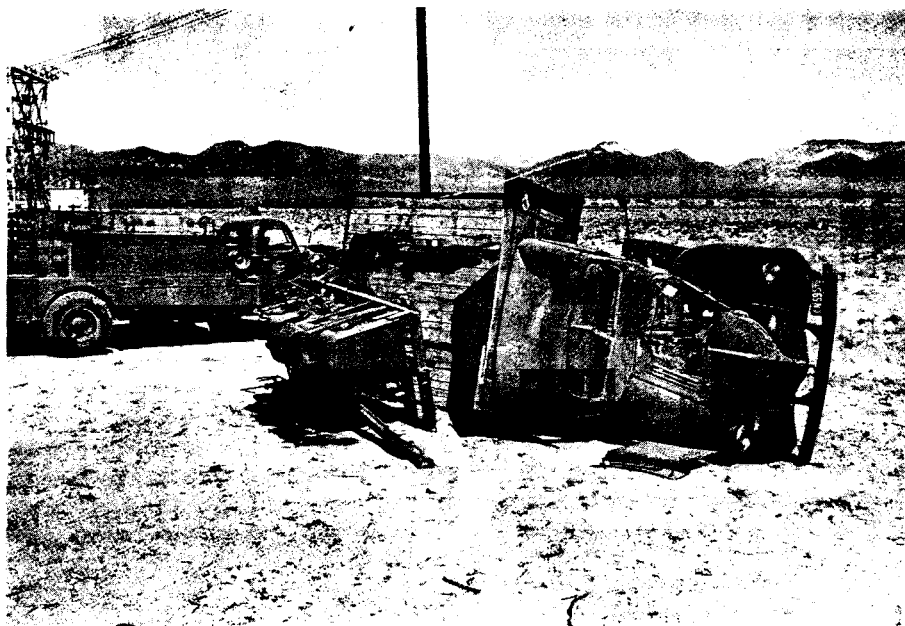
Figure 5.89. Truck broadside to the blast wave (5 psi peak overpressure) overturned; electric utility truck in background head-on to blast was damaged but remained standing.

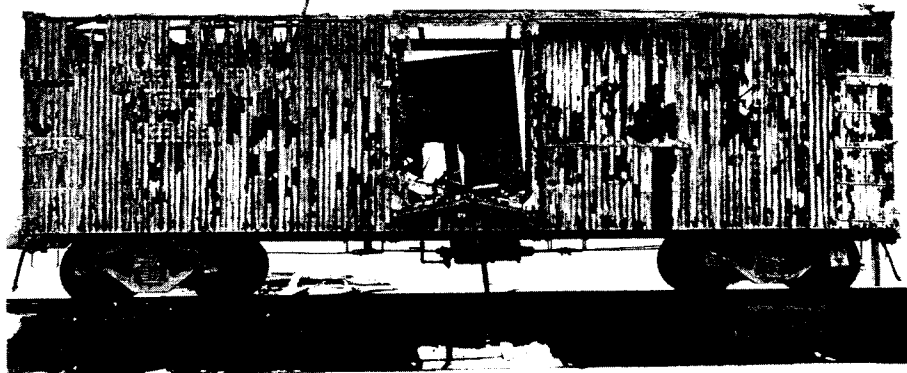
Figure 5.92a. Loaded wooden boxcar after a nuclear explosion (4 psi peak overpressure).

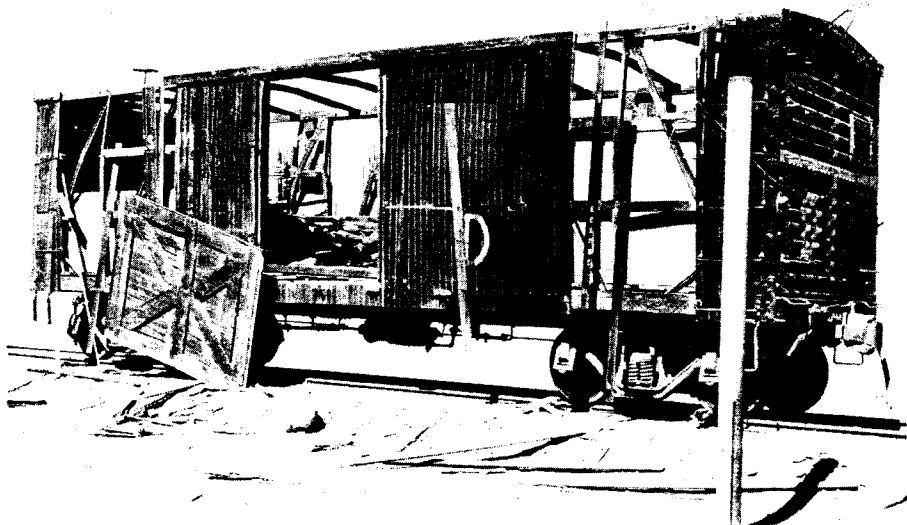
Figure 5.92b. Loaded wooden boxcar after a nuclear explosion (6 psi peak overpressure).

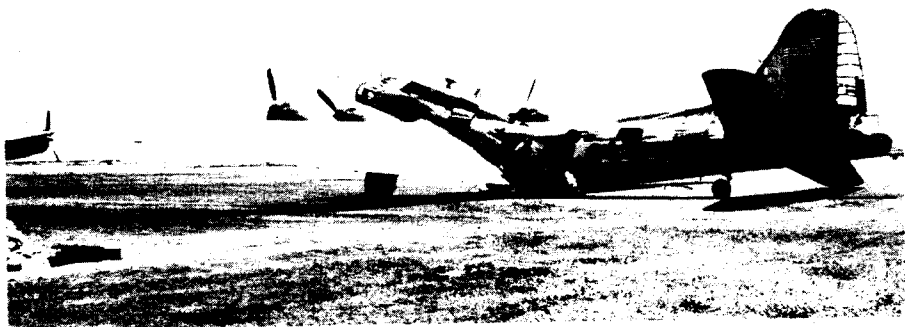
Figure 5.95a. Aircraft after side exposed to a nuclear explosion (3.6 psi peak overpressure).

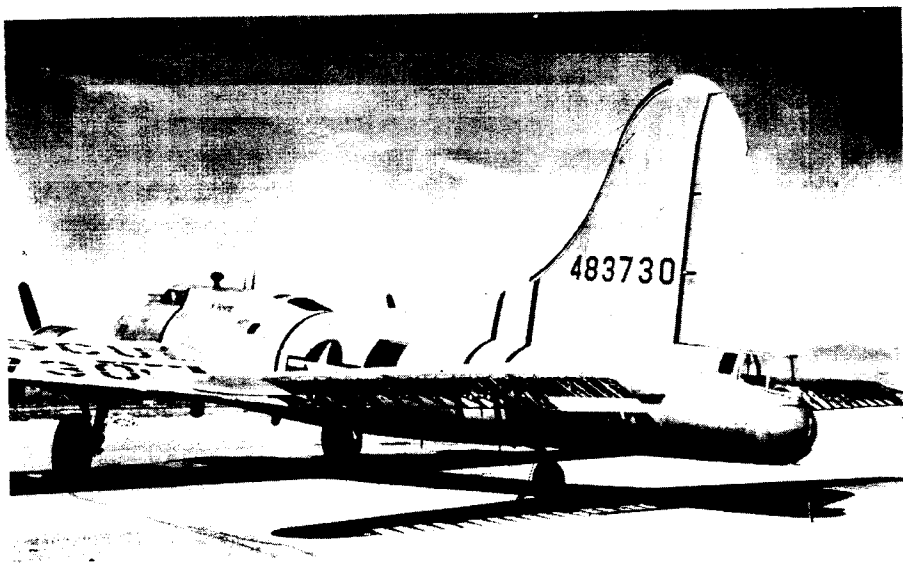
Figure 5.95b. Aircraft after tail exposed to a nuclear explosion (2.4 psi peak overpressure).

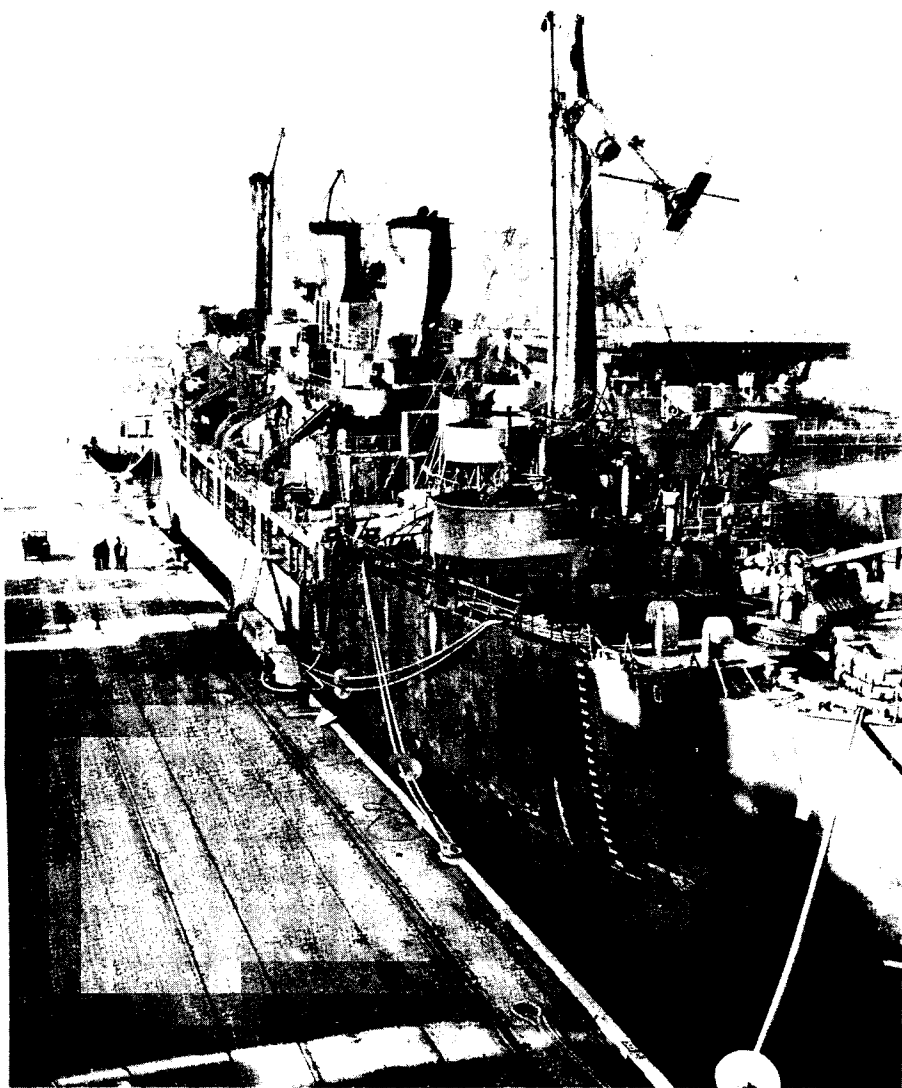
Figure 5.96. The U.S.S. Crittenden after ABLE test; damage resulting was generally serious (0.47 mile from surface zero).
