## CHAPTER V

# STRUCTURAL DAMAGE FROM AIR BLAST

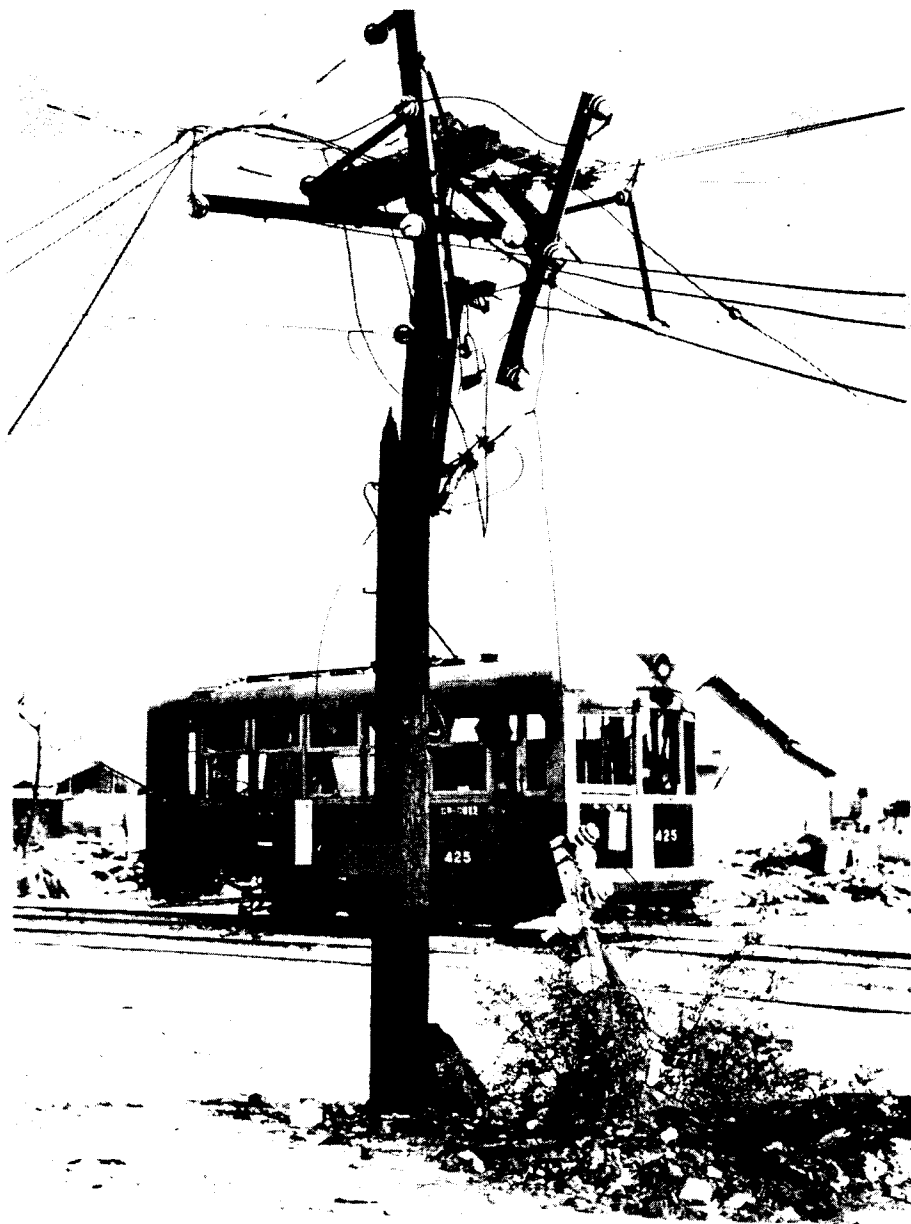
Figure 5.98. Damage to utility pole (0.80 mile from ground zero at Hiroshima).

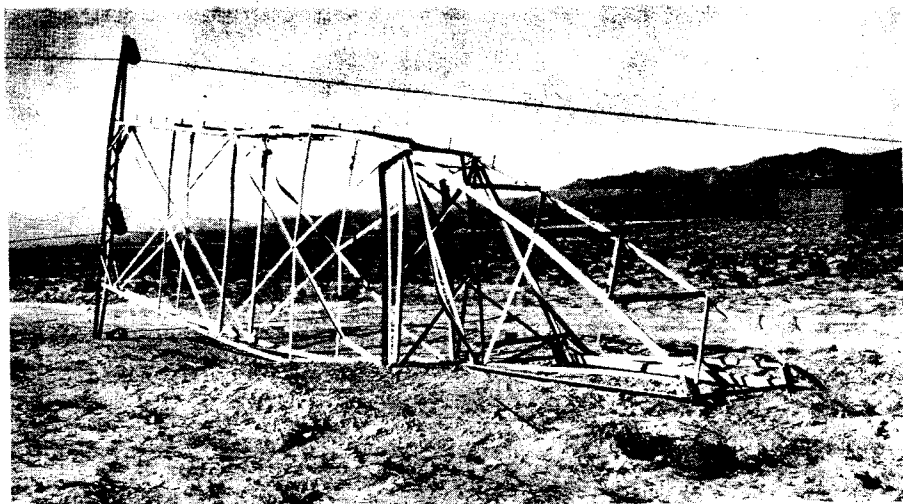
Figure 5.102a. Collapsed suspension tower (5 psi peak overpressure, 0.6 psi dynamic pressure from 30-kiloton explosion), Nevada Test Site.

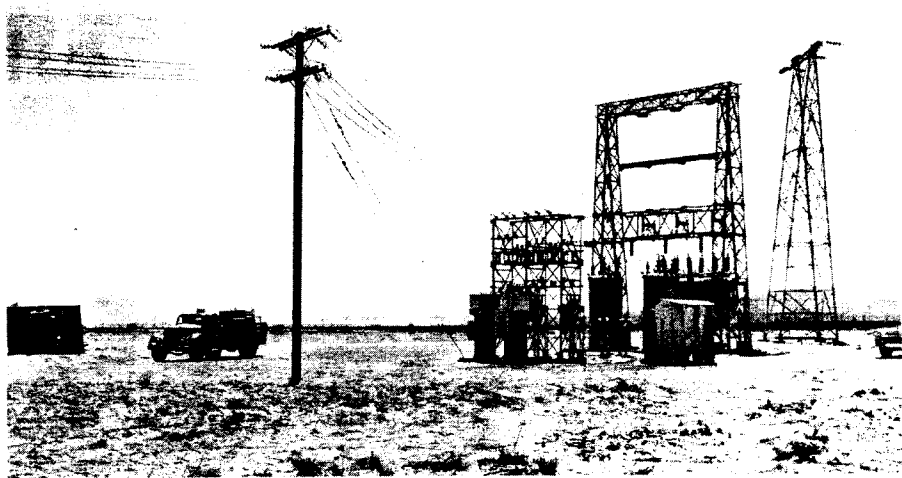
Figure 5.102b. Dead-end tower, suspension tower, and transformers (5 psi peak overpressure, 0.6 psi dynamic pressure from 30-kiloton explosion), Nevada Test Site. The trucks at the left of the photograph are those in Figure 5.89.

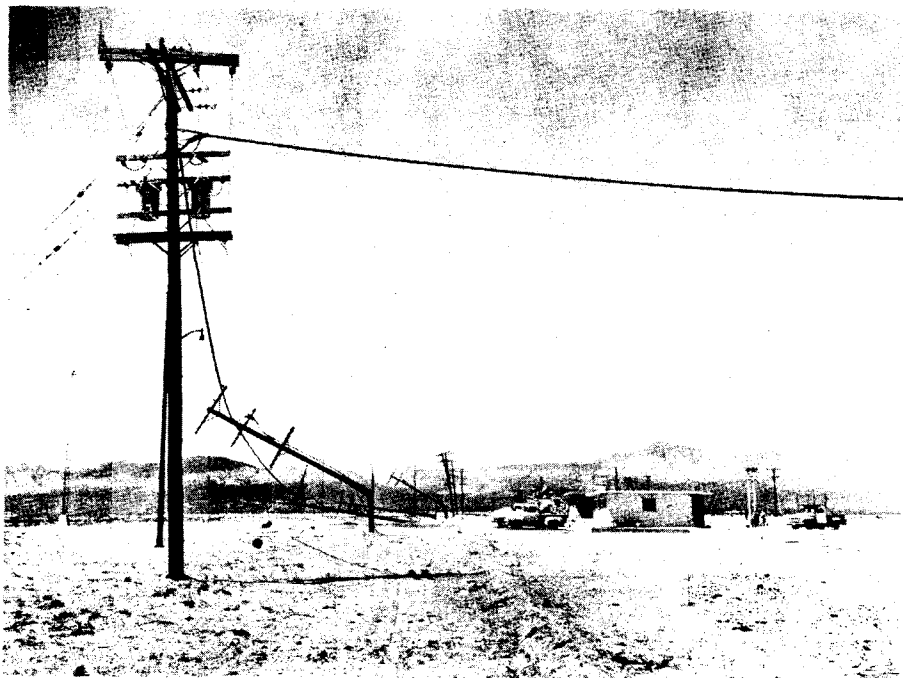
Figure 5.104. Collapse of utility poles on line (5 psi peak overpressure, 0.6 psi dynamic pressure from 30-kiloton explosion), Nevada Test Site.

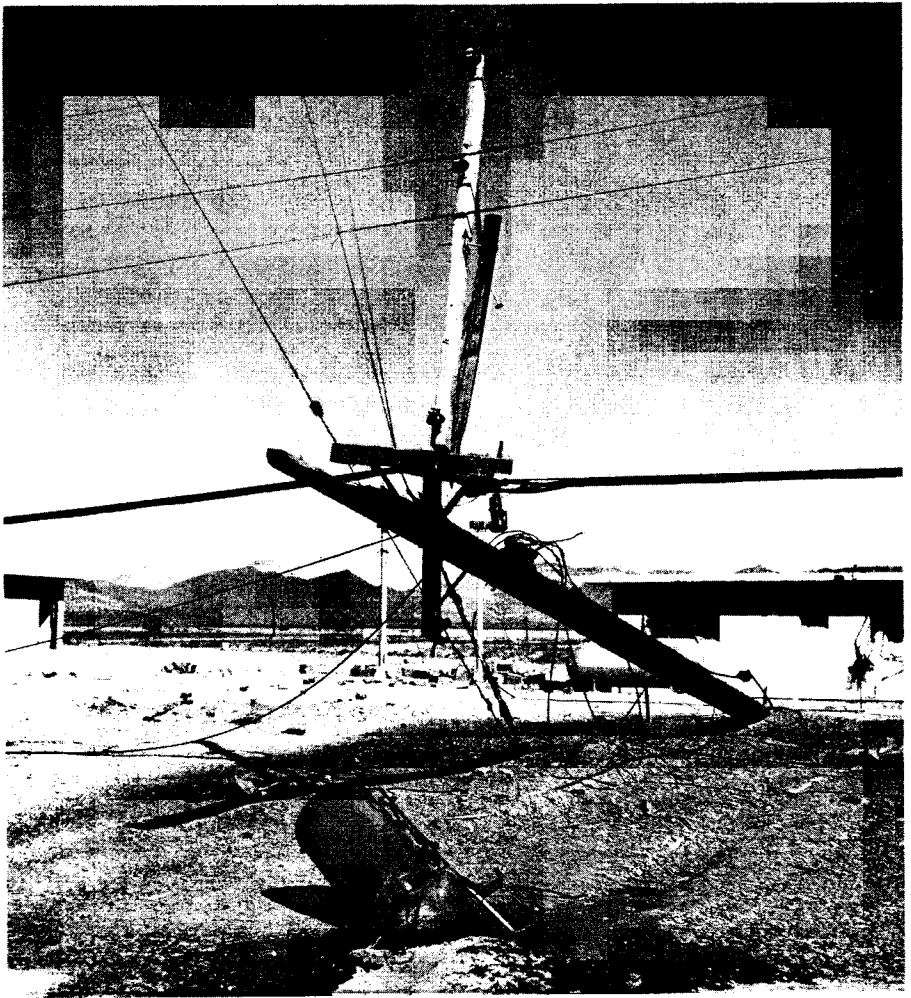
Figure 5.105. Transformer fallen from collapsed utility pole (5 psi peak overpressure), Nevada Test Site.

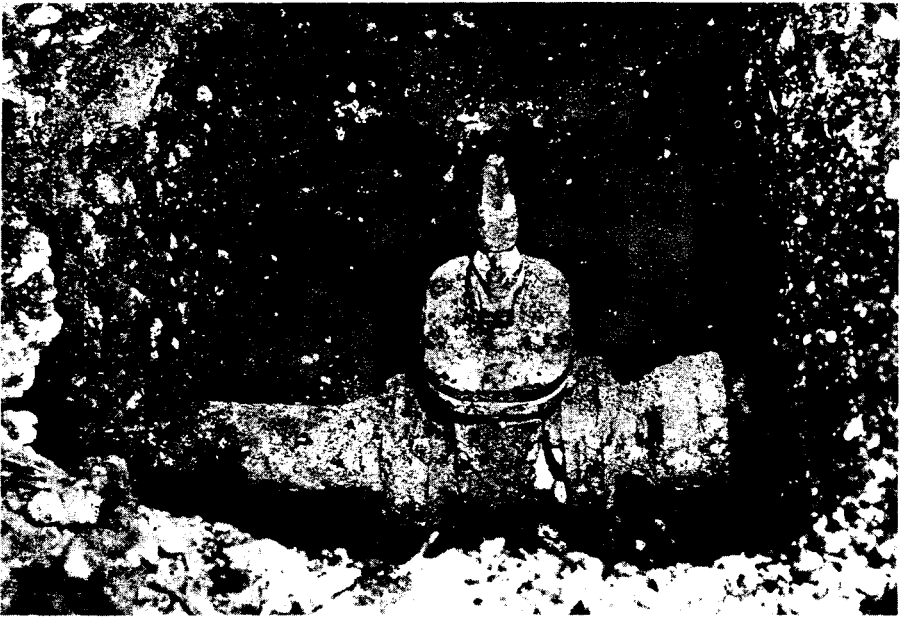
Figure 5.106a. Four-inch gate valve in water main broken by debris from brick wall (0.23 mile from ground zero at Hiroshima).

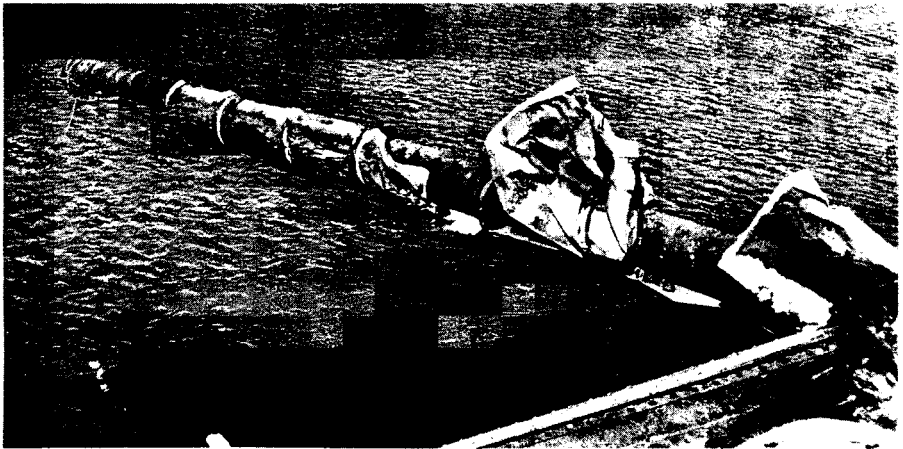
Figure 5.106b. Broken portion of 16-inch water main carried on bridge (0.23 mile from ground zero at Hiroshima).

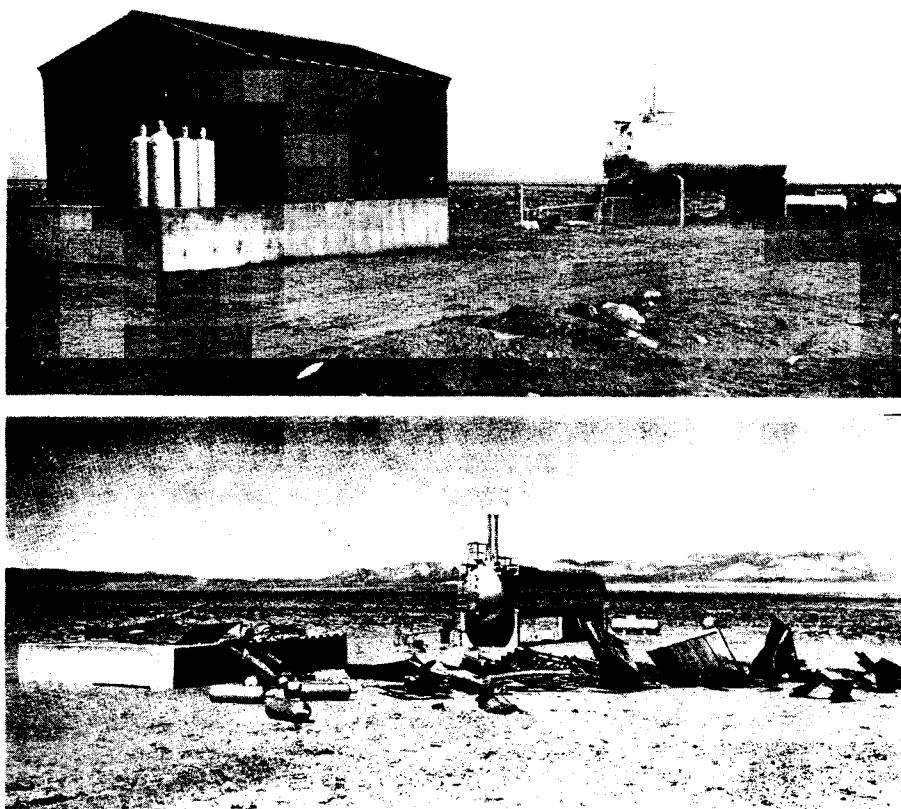
Figure 5.120. Upper photo: LP-gas bulk storage and filling plant before a nuclear explosion. Lower photo: The plant after the explosion (5 psi peak overpressure).

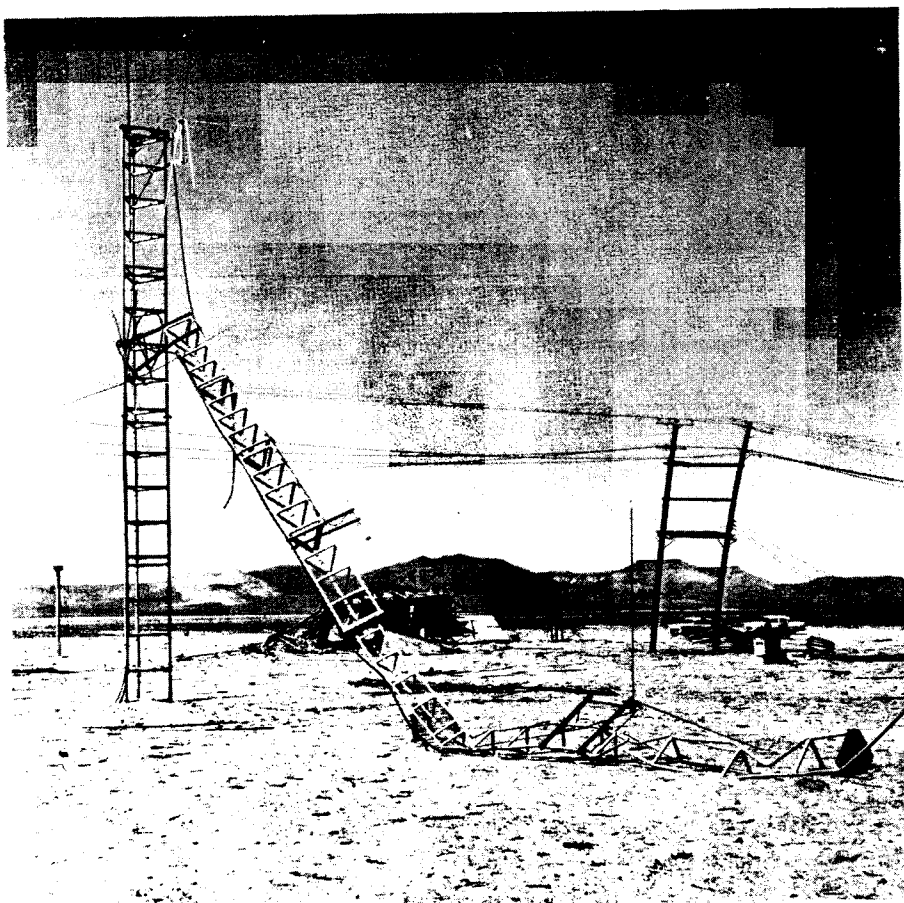
Figure 5.124. Unguyed lightweight 120-foot antenna tower (5 psi peak overpressure, 0.6 psi dynamic pressure from 30-kiloton explosion), Nevada Test Site.

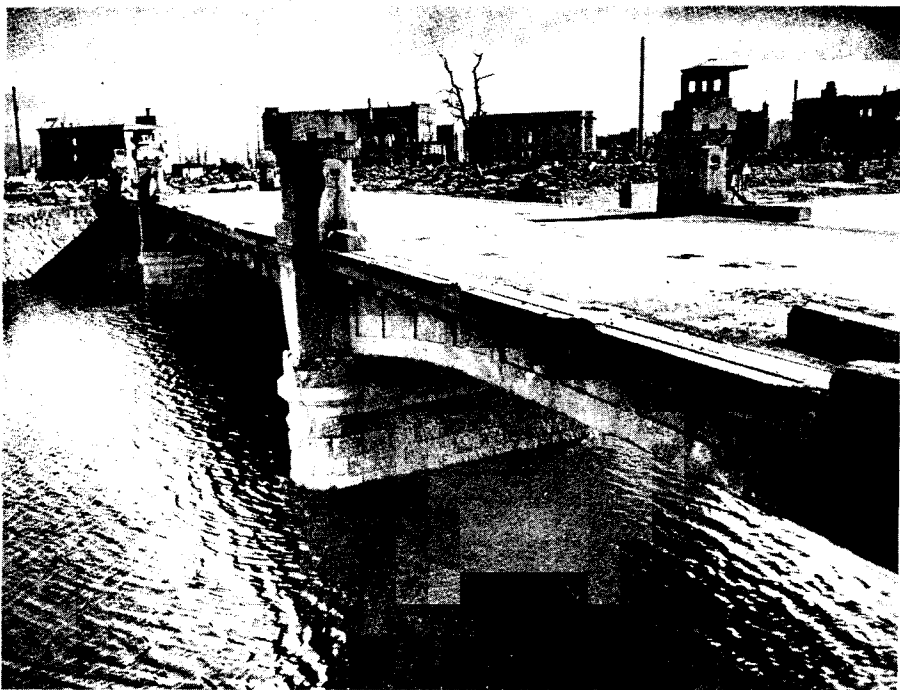
Figure 5.127a. Bridge with deck of reinforced concrete on steel-plate girders; outer girder had concrete facing (270 feet from ground zero at Hiroshima). The railing was blown down but the deck received little damage so that traffic continued.

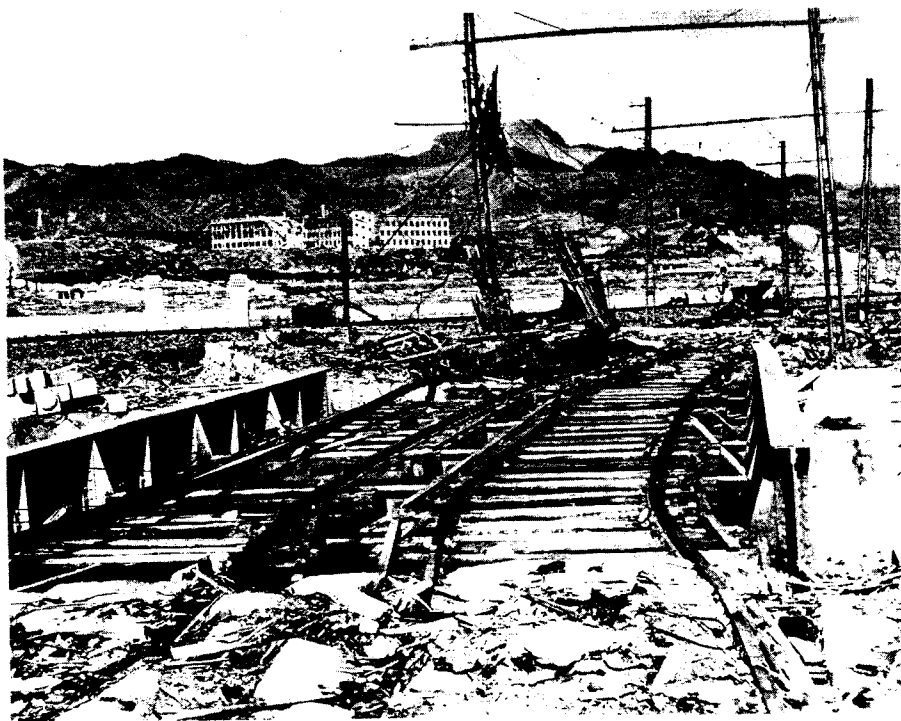
Figure 5.127b. A steel-plate girder, double-track railway bridge (0.16 mile from ground zero at Nagasaki). The plate girders were moved about 3 feet by the blast; the railroad track was bent out of shape and trolley cars were demolished, but the poles were left standing.

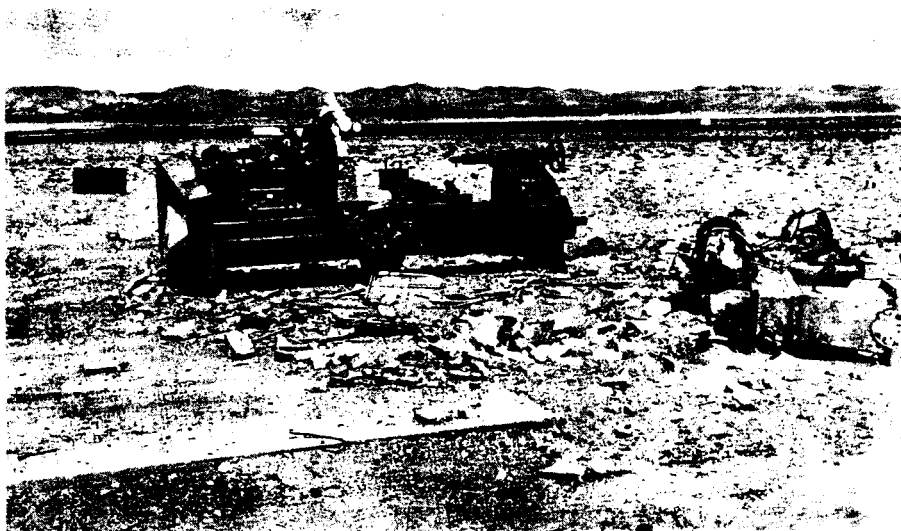
Figure 5.129a. Machine tools after a nuclear explosion (10 psi peak overpressure).

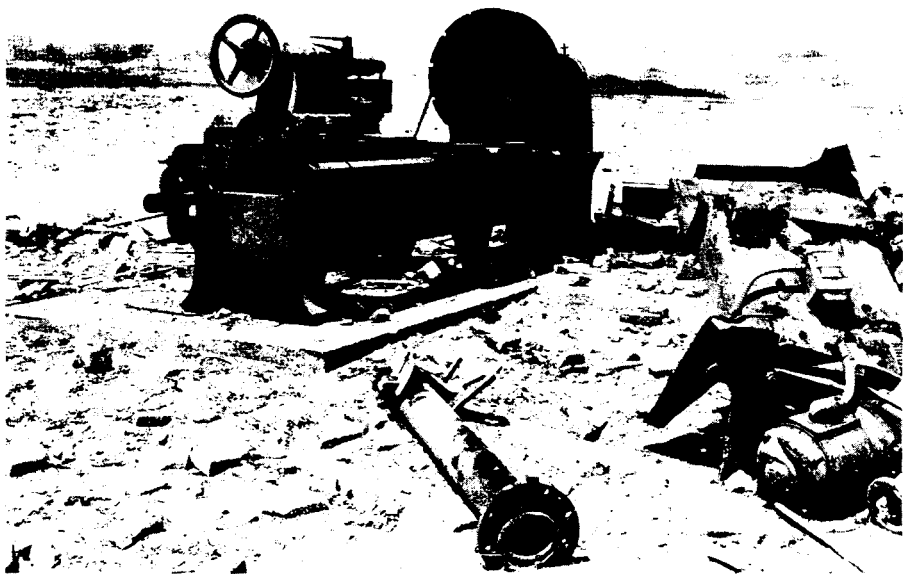
Figure 5.129b. Heavy-duty lathe after a nuclear explosion (10 psi peak overpressure).
