## CHAPTER V

# STRUCTURAL DAMAGE FROM AIR BLAST

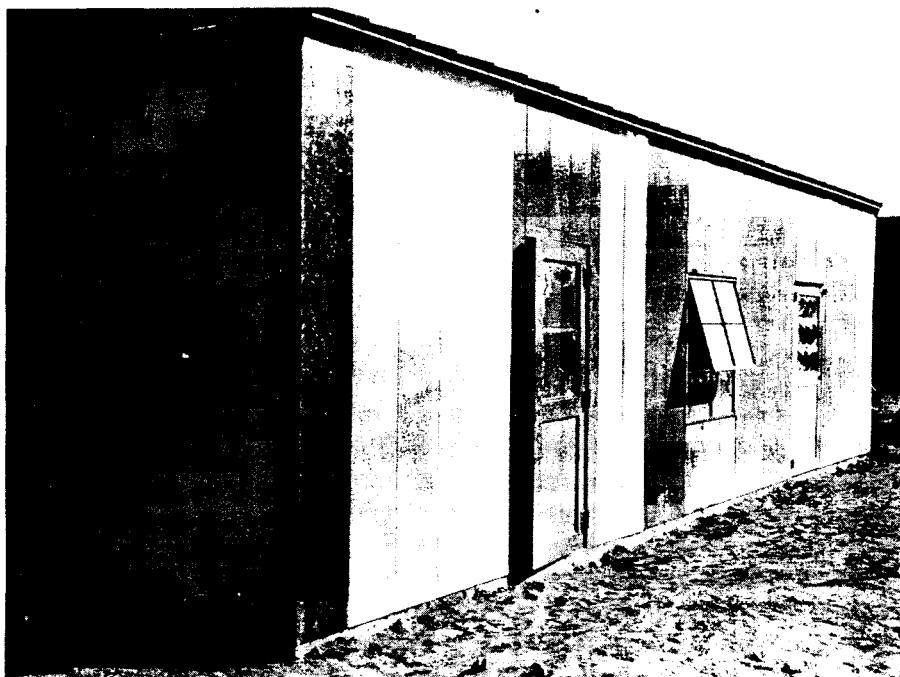
**5.40** A frameless structure with self-supporting walls and roof of light, channel-shaped, interlocking, steel panels (16 inches wide) represented the second standard type of industrial building (Fig. 5.40a). The one subjected to 3.1 pounds per square inch peak overpressure (and a dynamic pressure of

0.2 pound per square inch) was completely demolished (Fig. 5.40b). One or two segments of wall were blown as far as 50 feet away, but, in general, the bent and twisted segments of the building remained approximately in their original locations. Most of the wall sections were still attached to their foundation bolts on the side and rear walls of the

Figure 5.40a. Exterior of self-framing steel panel building before a nuclear explosion, Nevada Test Site.

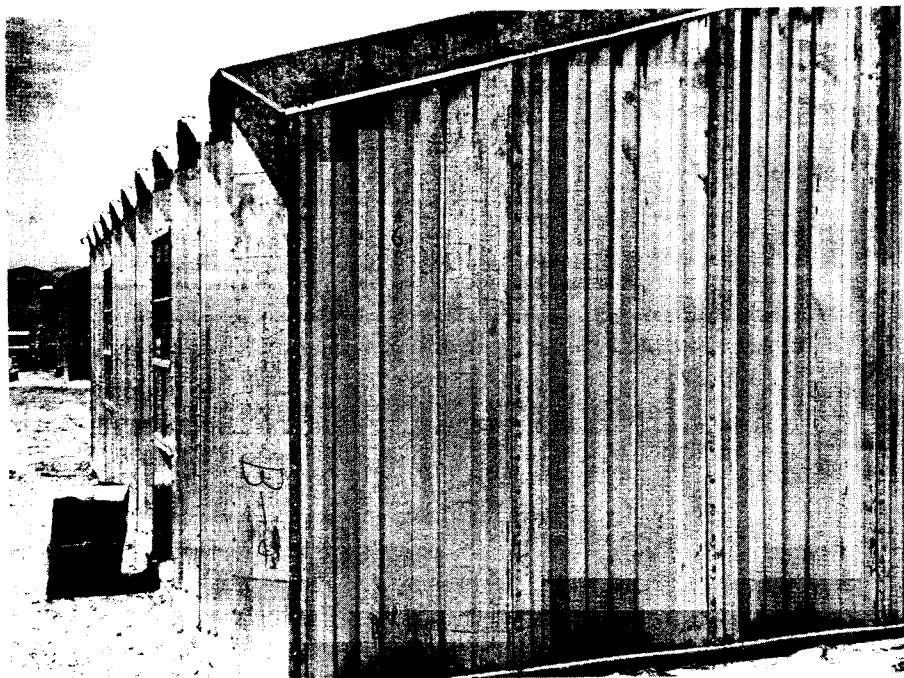
5.43 The third type of industrial building was a completely frameless structure made of strong, deeply-corrugated 43-inch wide panels of 16-gauge steel sheet. The panels were held together with large bolt fasteners at the sides and at the eaves and roof ridge. The wall panels were bolted to the concrete foundation. The entire structure was self-supporting, without frames, girts, or purlins (Fig. 5.43).

Figure 5.43. Self-framing corrugated steel panel building before a nuclear explosion, Nevada Test Site.

**5.44** At a peak overpressure of 3.1 and a dynamic pressure of 0.2 pound per square inch a structure of this type was badly damaged, but all the pieces remained bolted together, so that the structure still provided good protection from the elements for its contents. The front slope of the roof was crushed downward, from 1 to 2 feet, at midsection, and the ridge line suffered moderate deflection. The rear slope of the roof appeared to be essentially undamaged (Fig. 5.44).

**5.45** The front and side walls were buckled inward several inches, and the door in the front was broken off. All the windows were damaged to some extent, although a few panes in the rear remained in place.

**5.47** The corrugated steel, frameless structure proved to be the most blast-resistant of those tested. It is believed that, provided the overpressure did not exceed about 3 pounds per square inch, relatively minor repairs would make possible continued use of the building. Improvement in the design of doors and windows, so as to reduce the missile hazard from broken glass, would be advantageous.

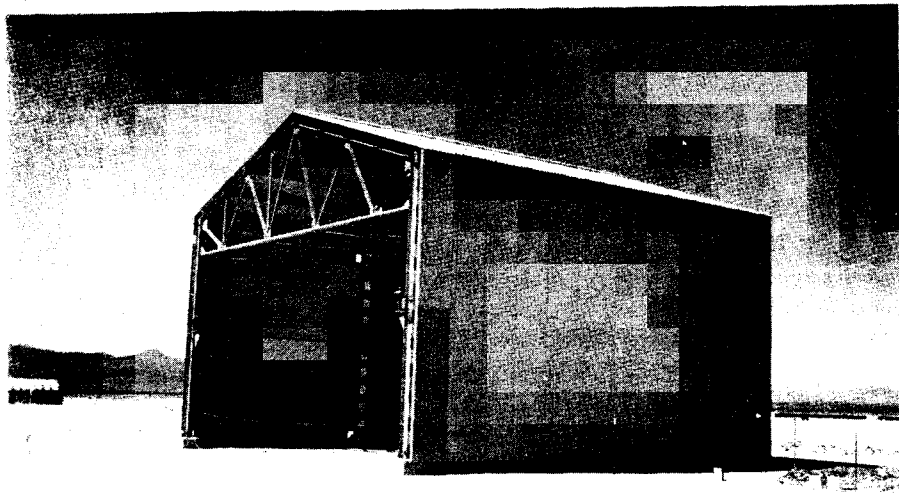
Figure 5.48a. Steel-frame building with siding and roof of frangible material.

tions in the kiloton and megaton ranges. Two representative types of small industrial buildings were chosen for these tests. One had a steel frame covered with siding and roofing of a frangible material and was considered to be a drag-type structure (Fig. 5.48a). The other had the same steel frame and roofing, but it had concrete siding with a window opening of about 30 percent of the wall area; this was regarded as a semidrag structure (Fig. 5.48b).

bolts failed, and yielding was found between the lower chord (horizontal member of the roof truss) and column connections. The girts on the windward side were severely damaged and all of the siding was completely blown off (Fig. 5.49).

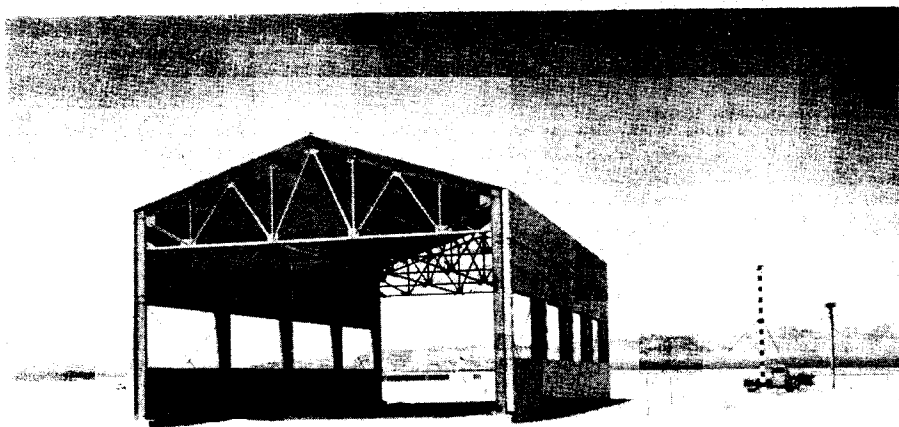
Figure 5.48b. Steel-frame building with concrete siding and window openings of 30 percent of the wall area.

**5.50** The second building, with the stronger siding, was exposed in Nevada to a peak overpressure loading of about 3.5 and a dynamic pressure of 0.3 pounds per square inch, with a positive phase duration of 1 second. Damage to this structure was small (Fig. 5.50). Although almost the whole of the frangible roof was blown off, the only other damage observed was a small yielding at some connections and column bases.

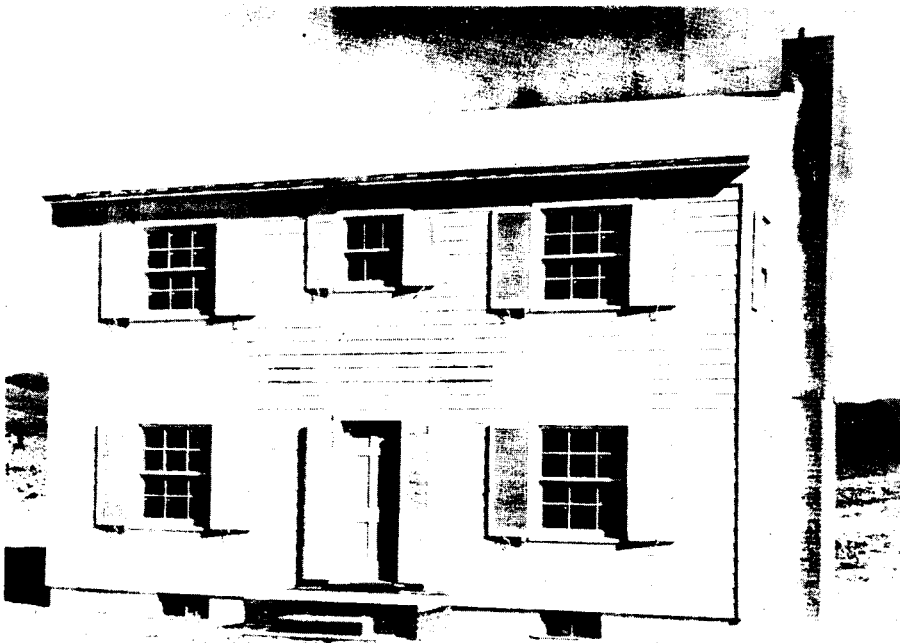
different locations. They were of typical wood-frame construction, with two stories, basement, and brick chimney (Fig. 5.55). The interiors were plastered but not painted. Since the tests were intended for studying the effects of blast, precautions were taken to prevent the houses from burning. The exteriors were consequently painted white (except for the shutters), to reflect the thermal radiation. For the same purpose, the windows facing the explosion were equipped with metal venetian blinds having an aluminum finish. In addition, the houses were roofed with light-gray shingles; these were of asbestos cement for the house nearer to the explosion where the chances of fire were greater, whereas asphalt shingles were used for the other house. There were no utilities of any kind.

**5.56** One of the two houses was located in the region of Mach reflection where the peak incident overpressure was close to 5 pounds per square inch. It was expected, from the effects in Japan, that this house would be almost completely destroyed—as indeed it was—but the chief purpose was to see what protection might be obtained by persons in the basement.

**5.57** Some indication of the blast damage suffered by this dwelling can be obtained from Fig. 5.57. It is apparent that the house was ruined beyond repair. The first story was completely demolished and the second story, which was very badly damaged, dropped down on the first floor debris. The roof was blown off in several sections which landed at both front and back of the house. The gable end walls were blown apart and outward, and the brick chimney was broken into several pieces.

Figure 5.55. Wood-frame house before a nuclear explosion, Nevada Test Site.

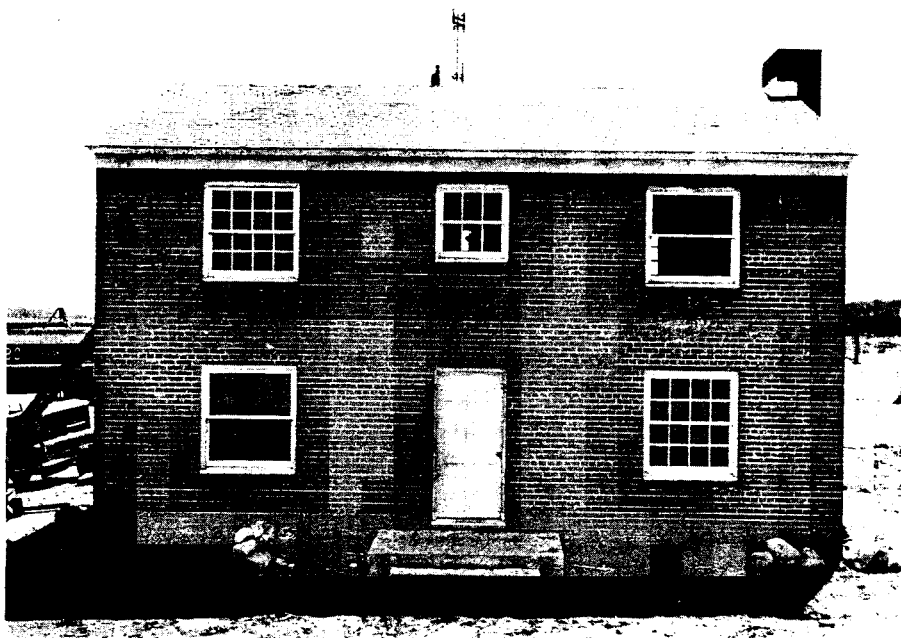
**5.66** For comparison with the tests on the two-story, wood-frame structures made in Nevada in 1953, two brick-wall-bearing houses of conventional construction, similar in size and layout, were exposed to 5 and 1.7 pounds per square inch peak overpressure, respectively, in the 1955 tests (Fig. 5.66). The exterior walls were of brick veneer and cinder block and the foundation walls of cinder block; the floors, partitions, and roof were wood-framed.

**5.67** At an incident peak overpressure of 5 pounds per square inch, the brick-wall house was damaged beyond

Figure 5.66. Unreinforced brick house before a nuclear explosion, Nevada Test Site.

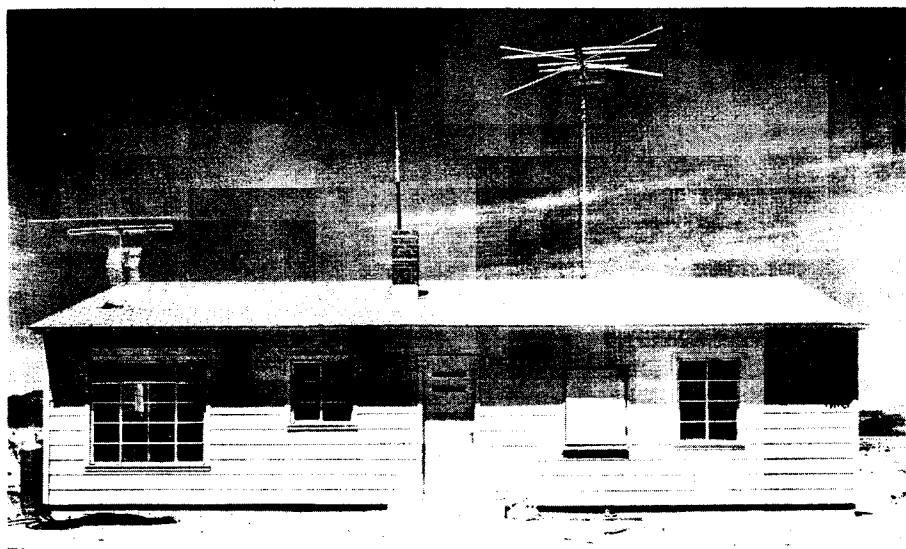
5.69 A pair of the so-called "rambler" type, single-story, wood-frame houses were erected at the Nevada Test Site on concrete slabs poured in place at grade. They were of conventional design except that each contained a shelter, above ground, consisting of the bathroom walls, floor, and ceiling of reinforced concrete with blast door and shutter (Fig. 5.69).

Figure 5.69. Rambler-type house before a nuclear explosion, Nevada Test Site. (Note blast door over bathroom window at right.)

**5.70** When exposed to an incident peak overpressure of about 5 pounds per square inch, one of these houses was demolished beyond repair. However, the bathroom shelter was not damaged at all. Although the latch bolt on the blast shutter failed, leaving the shutter unfastened, the window was still intact. The roof was blown off and the rafters were split and broken. The side walls at gable ends were blown outward, and fell to the ground. A portion of the front wall remained standing, although it was leaning away from the direction of the explosion (Fig. 5.70).

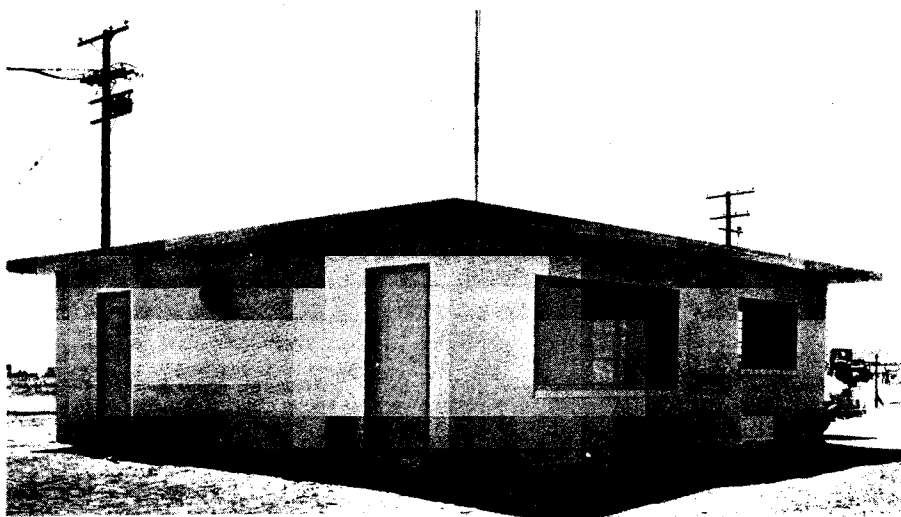
**5.77** At a peak overpressure of about 5 pounds per square inch, windows were destroyed and doors blown in the demolished. The steel window-sash was distorted, but nearly all remained in place. The house suffered only minor structural damage and could have been made habitable at relatively small cost (Fig. 5.77).

**5.78** There was some evidence that the roof slabs had been moved, but not sufficiently to break any connections. The masonry wall under the large window (see Fig. 5.77) was pushed in about 4 inches on the concrete floor slab; this appeared to be due to the omission of dowels between the walls and the floor beneath window openings. Some cracks developed in the wall above the same window, probably as a result of improper installation of the reinforced lintel course and the substitution of a pipe

Figure 5.76. Reinforced masonry-block house before a nuclear explosion, Nevada Test Site.

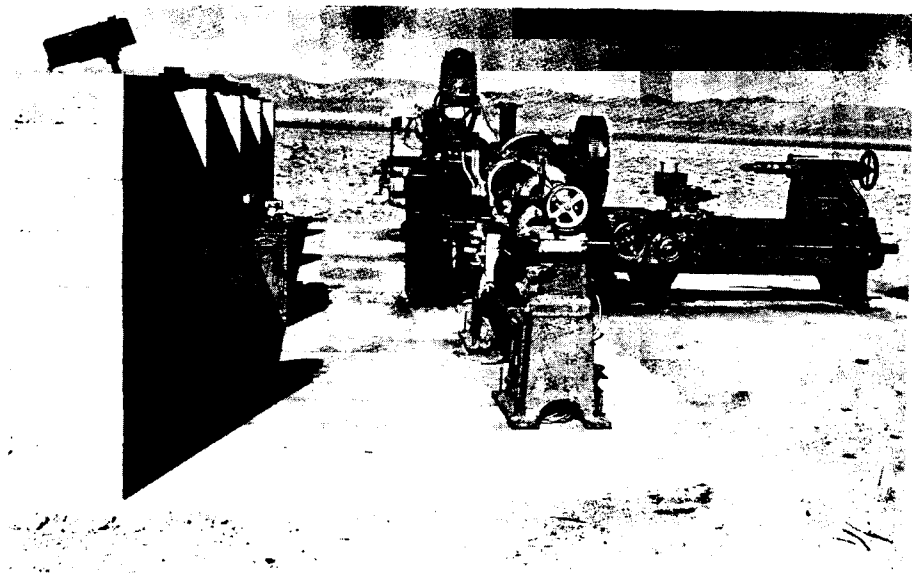
much of which resulted from the expected complete demolition of the concrete-block wall. Delicate mechanisms and appendages, which are usually on the exterior and unprotected, suffered especially severely. Gears and gear cases were damaged, hand valves and control levers were broken off, and drive belts were broken. It appears, however, that most of the missile damage could be easily repaired if replacement parts were available, since major dismantling would not be required.

Figure 5.128. Machine tools behind masonry wall before a nuclear explosion, Nevada Test Site.

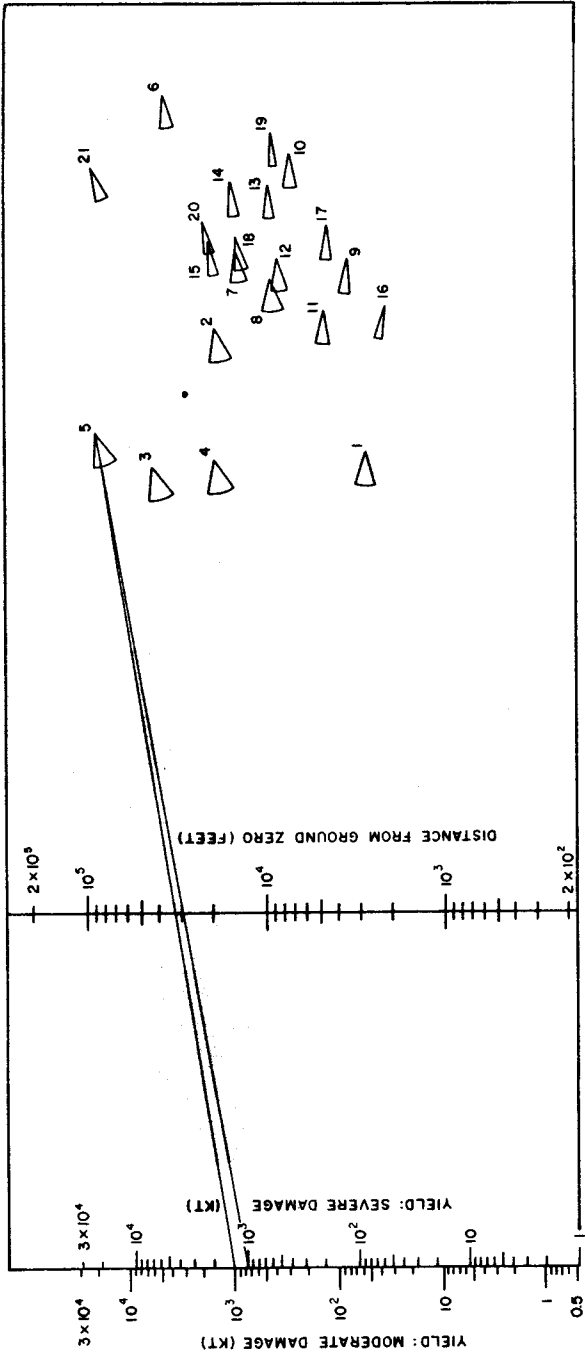
**5.140** The ranges for severe and moderate damage to the structures in Tables 5.139a and b are presented in Fig. 5.140, based on actual observations and theoretical analysis. The numbers (1 to 21) in the figure identify the target types as given in the first column of the tables. The data refer to air bursts with the height of burst chosen so as to maximize the radius of damage for the particular target being considered and is not necessarily the same for different targets. For a surface burst, the respective ranges are to be multiplied by three-fourths. An example illustrating the use of the diagram is given.

The various above-ground structures in Fig. 5.140 are identified (Items 1 through 21) and the different types of damage are described in Tables 5.139a and b. The "fan" from each point indicates the range of yields for which the diagram may be used. For a surface burst multiply the damage distances obtained from the diagram by three-fourths. The results are estimated to be accurate within  $\pm 20$  percent for the average target conditions specified in § 5.141.

Figure 5.140. Damage-distance relationships for above ground structures.

**5.141** The data in Fig. 5.140 are for certain average target conditions. These are that (1) the target is at sea level (no correction is necessary if the target altitude is less than 5,000 feet); (2) the terrain is fairly flat (rugged terrain would provide some local shielding and protection in certain areas and local enhancement of damage in others); and (3) the structures have average characteristics (that is, they are of average size and strength and that orientation of the target with respect to the burst is no problem, i.e., that the ratio of loading to resistance is relatively the same in all directions from the target).

**5.143** Figure 5.140 gives the distances from ground zero for severe and moderate damage. Light damage to all targets except blast-resistant structures and bridges can be expected at the range at which the overpressure is 1 pound per square inch. For the blast-resistant structure (Type 1) described in Table 5.139a, a peak overpressure of 10 pounds per square inch should be used to estimate the distance for light damage. Light damage to bridges can be expected at the range at which 0.6

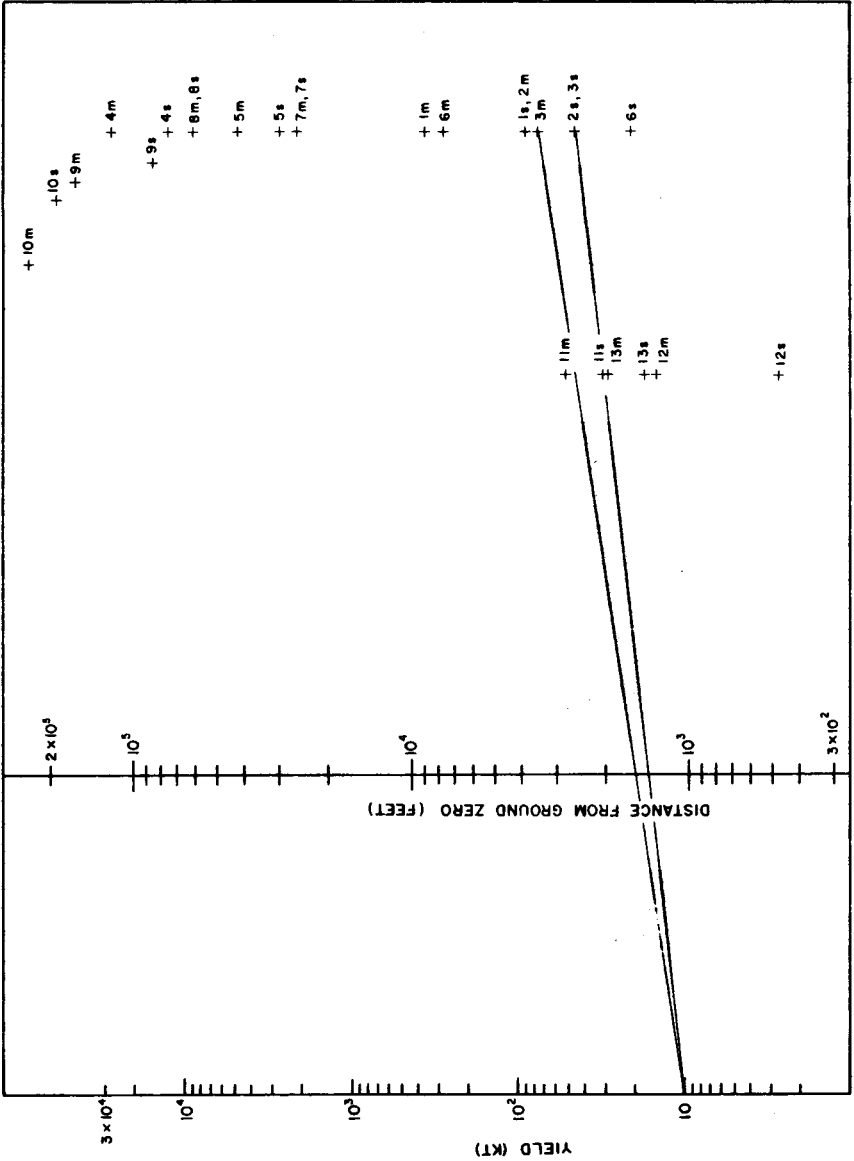
**5.146** A diagram of damage-distance relationships for various targets which are largely affected by drag forces is given in Fig. 5.146. The conditions under which it is applicable and the

Figure 5.146. Damage-distance relationships for drag-sensitive targets.

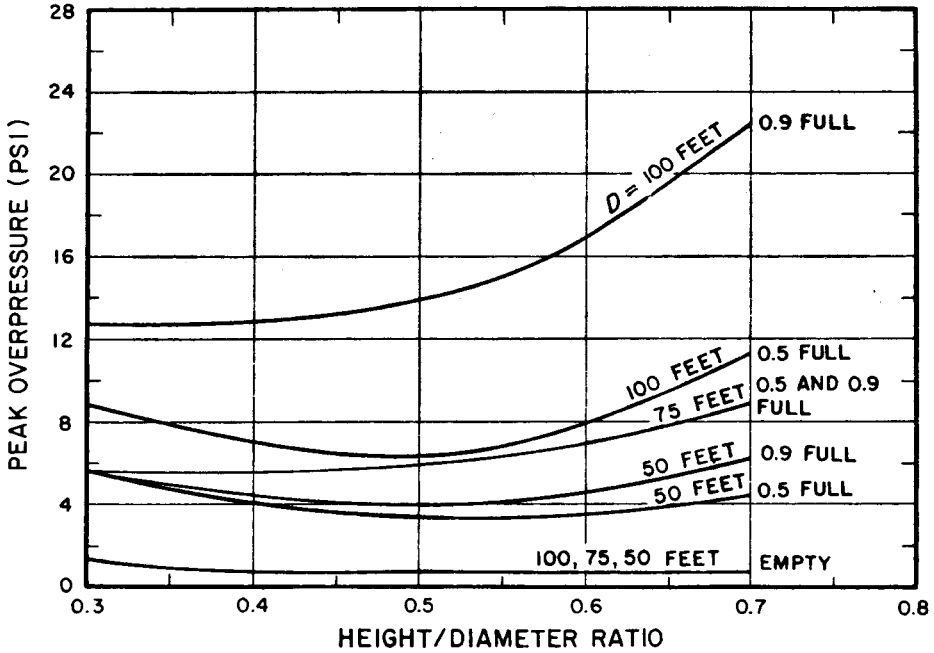
from the tank as a consequence of sloshing. There is apparently no clear-cut overall structural collapse which initially limits the usefulness of the tank. Peak overpressures required for severe damage to POL tanks of diameter  $D$  may be obtained from Figs. 5.155a and b. Figure 5.155a is applicable to nuclear explosions with energy yields from 1 to 500 kilotons and Fig. 5.155b to yields over 500 kilotons. For yields less than 1 kiloton, the peak overpressure for severe damage may be taken to be 1 pound per square inch.

Figure 5.155a. Peak overpressures for severe blast damage to floating- or conical-roof tanks of diameter  $D$  for explosions from 1 to 500 kilotons.

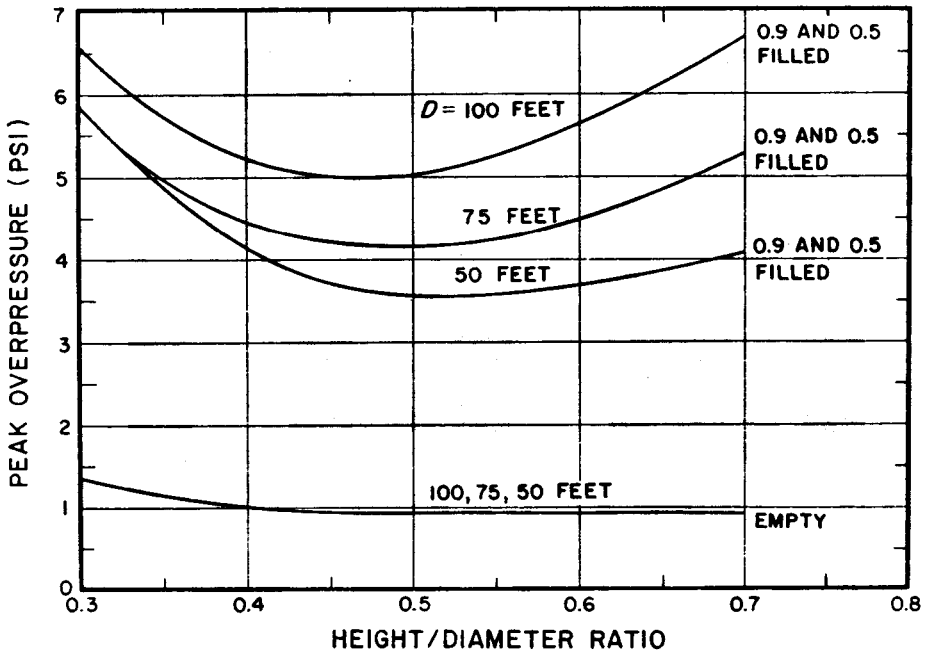
Figure 5.155b. Peak overpressures for severe blast damage to floating- or conical-roof tanks of diameter  $D$  from explosions of 500 kilotons or more.
